Divisional Inquiry

M.V. Quinsam

**Unexpected Departure from
Nanaimo Harbour Terminal**

Divisional Inquiry No.: 815-07-01
Release Date: January 26, 2007

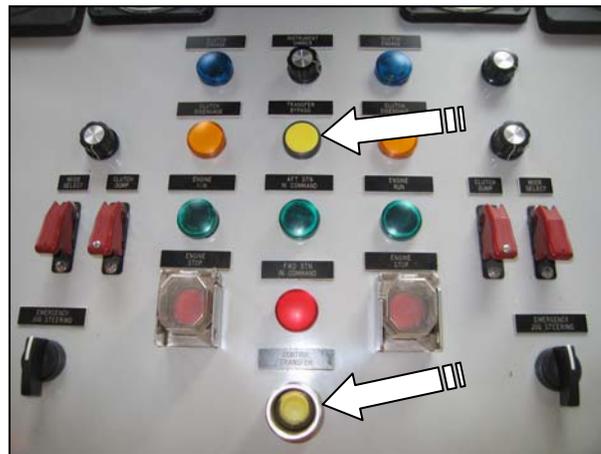
- From the console not in command, a "Hot Transfer" can be initiated. A hot transfer is when the console in command has all four RAD units clutched in and operating at a selected rpm and the console not in command is selected by depressing two buttons simultaneously. Control of the four RAD units is then assumed at that station and the RAD units will rotate to the combinator's azimuth and rpm selected at that station.

Hot Transfer can be done by depressing the two yellow buttons simultaneously.

12. All combinator control heads on RAD equipped vessels should be marked visually and with tactile strips to assist in night time operations.
13. A control transfer audio warning alarm which indicates transfer of control between consoles should be installed on all RAD vessels.

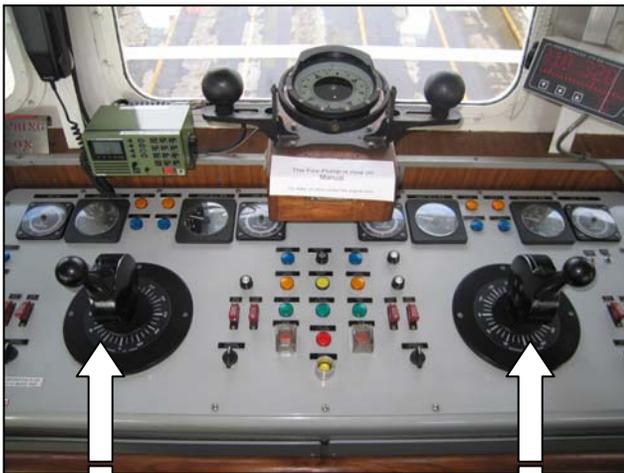
15. When all control and propulsion units are operating normally, there are two methods to rotate RAD units. One combinator controls RAD units #1 and #2. The other combinator controls RAD units #3 and #4.

This combinator controls #1 and #2 RAD units at #1 console.

This combinator controls #3 and #4 RAD units at #1 console.

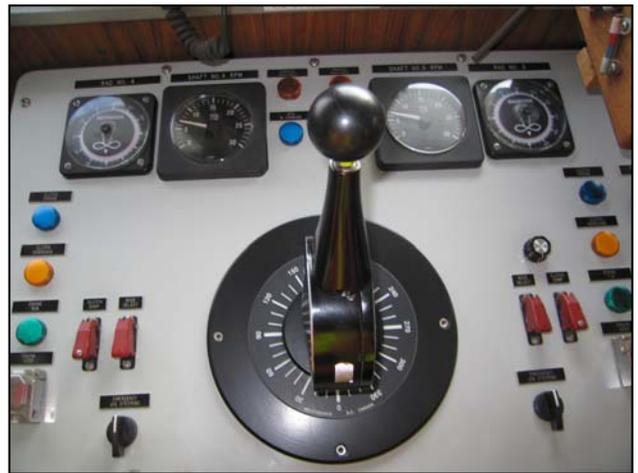
Close up of combinator and azimuth gauge indicating thrust of RAD units #3 and #4 and rpm settings.

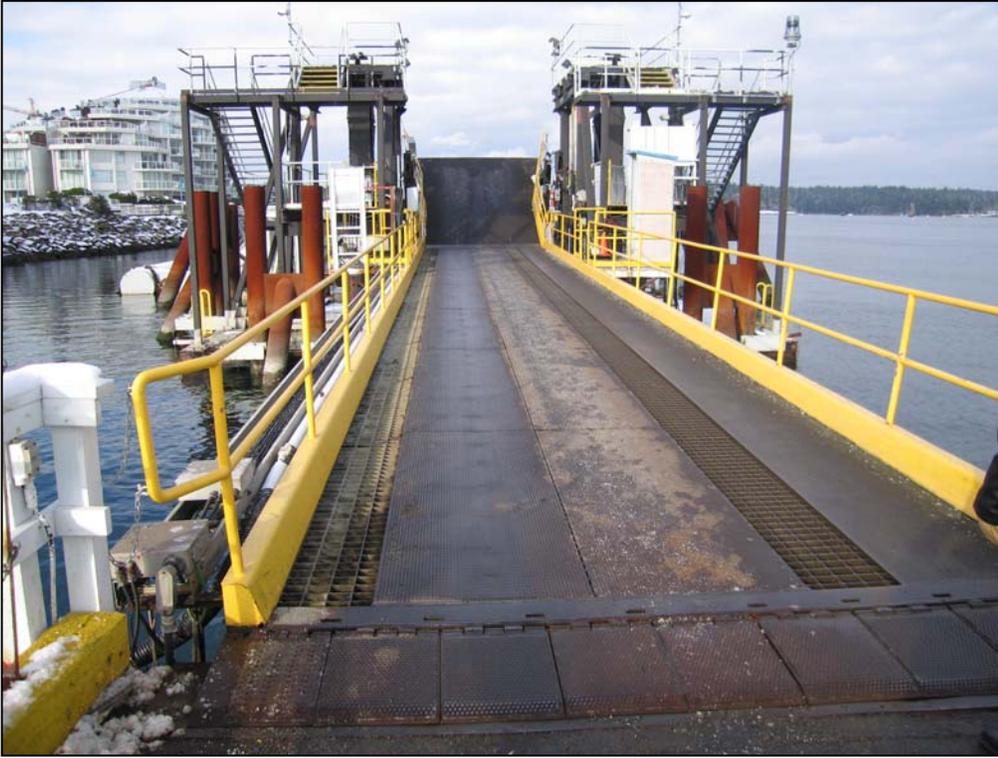
Nanaimo Harbour Terminal Ramp and Raised Apron

- On January 10th, 2007, BCFS Terminal Maintenance inspected and tested the Nanaimo Harbour main ramp and apron and associated components.
 - The apron hoist unit and hoist cable were replaced.

- The port side tie up cable system cable and chain were replaced.
 - All other components were found in good condition and safe and operable.
 - The Nanaimo Harbour main ramp and apron were certified for full operation.

7. In support of existing BCFS policy, all terminal aprons should be painted yellow and black indicating a *No Stopping Zone* to alert employees and customers.
