WATER QUALITY MONITORING AGREEMENT

WATER QUALITY ASSESSMENT OF COLUMBIA RIVER AT WANETA (1979 – 2000)

Prepared by:
Water, Air and Climate Change Branch
Ministry of Water, Land and Air Protection

February, 2002

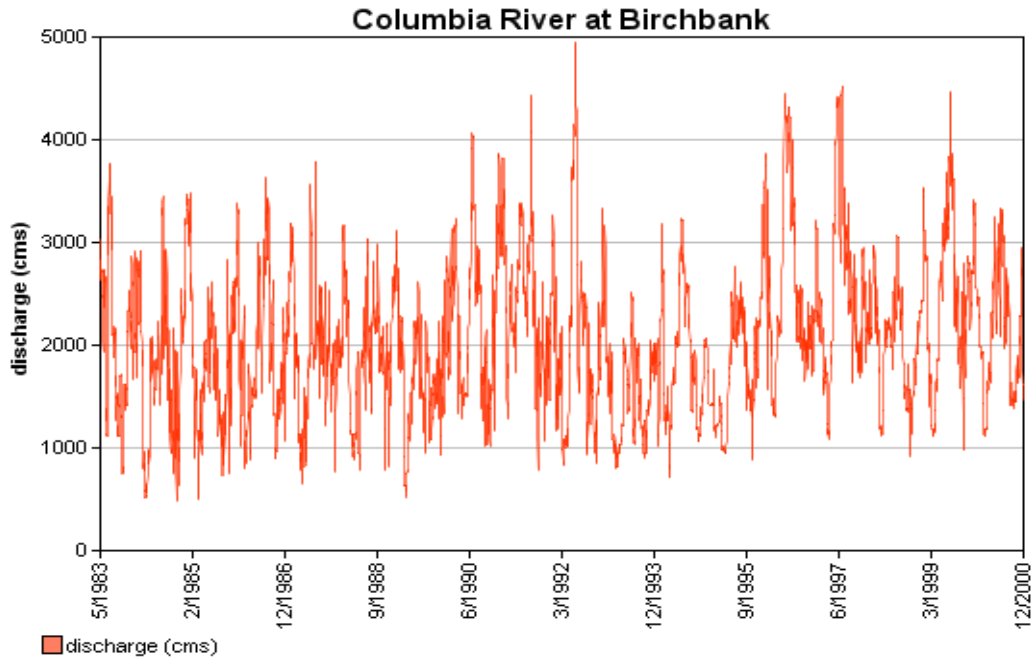
FIGURE 2 FLOW AT THE COLUMBIA RIVER AT BIRCHBANK

Flow in the Columbia River at Birchbank, about 25 km upstream from the Waneta station, has been monitored since 1937. The drainage area at Birchbank is 88,100 km², or about 99% of the drainage area at Waneta, and thus the flows at Birchbank are a good approximation of the flows at Waneta. The flow data are stored on the Water Survey of Canada database under station number BC08NE049. Twenty-two years (1979-2000) of flow data are plotted in Figure 2.
