WATER QUALITY MONITORING AGREEMENT

WATER QUALITY ASSESSMENT OF KETTLE RIVER AT CARSON (1980 – 2002)

Prepared by:
Burke Phippen
BWP Consulting

January, 2003

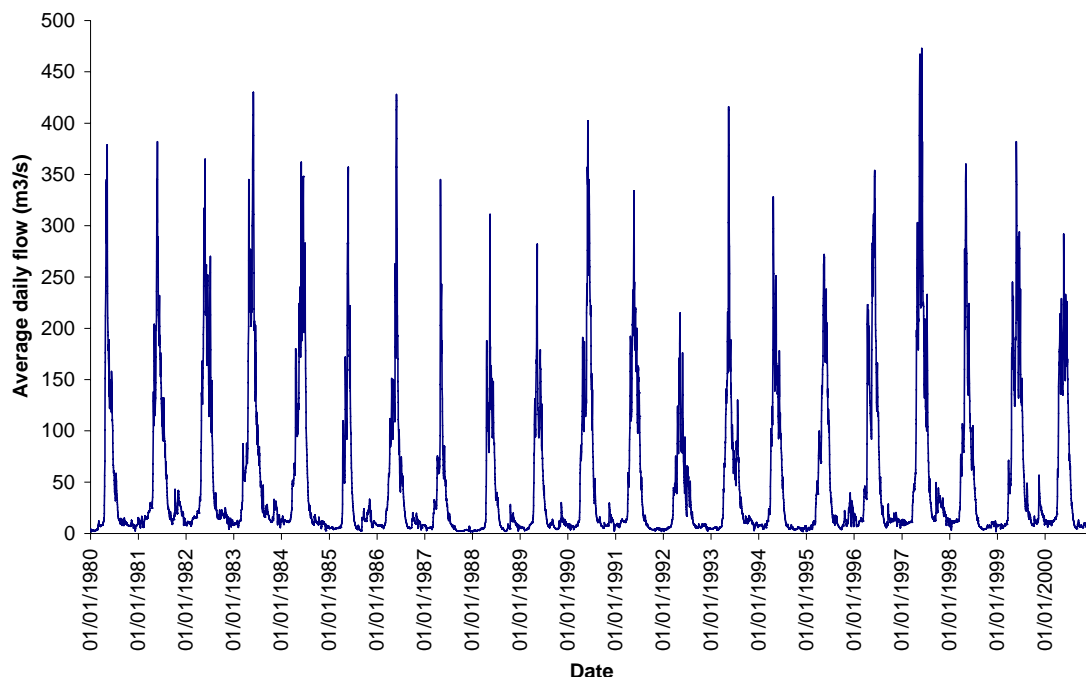
Figure 2. Kettle River at Ferry Flow (1980 - 2000)

The Kettle River at Carson is located just upstream and south west from Grand Forks, B.C. where the Kettle River makes its return into Canada, crossing back into B.C. from Washington State (Figure 1). The drainage area of the Kettle River at Carson watershed is 6730 km². The river flow is monitored at the nearest upstream Environment Canada station number BC08NN013 (Kettle River at the ferry crossing). The flow data are plotted in Figure 2.

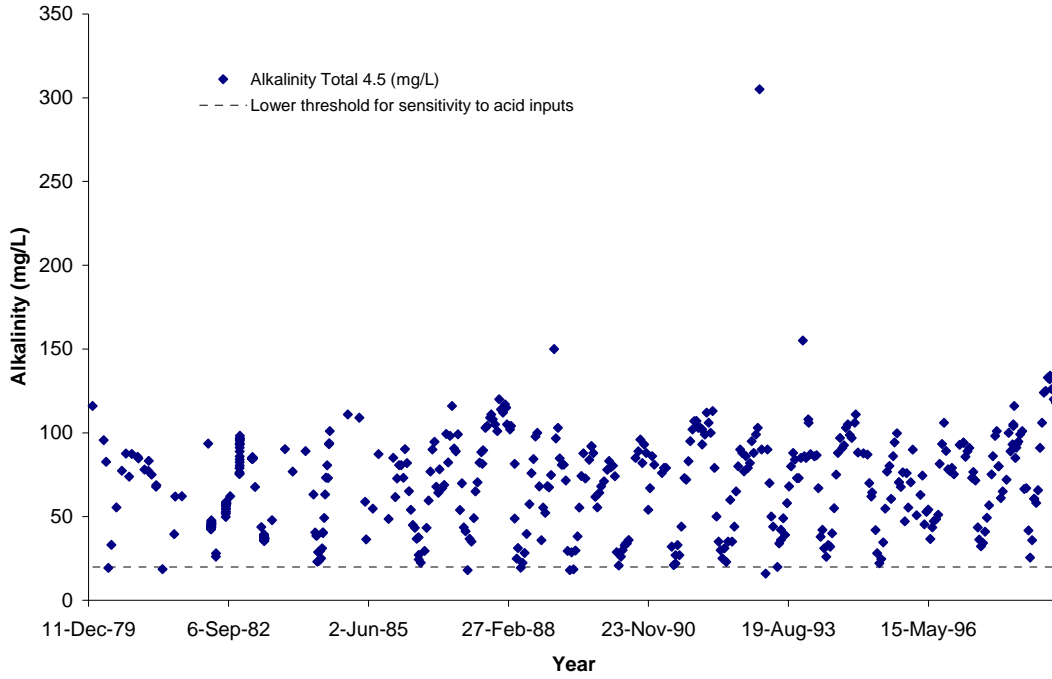
Figure 3. Kettle River at Carson - Alkalinity, Total

Total alkalinity (Figure 3) and **dissolved calcium** (Figure 11) concentrations indicate that the Kettle River at Carson is well buffered and has a low sensitivity to acid inputs.

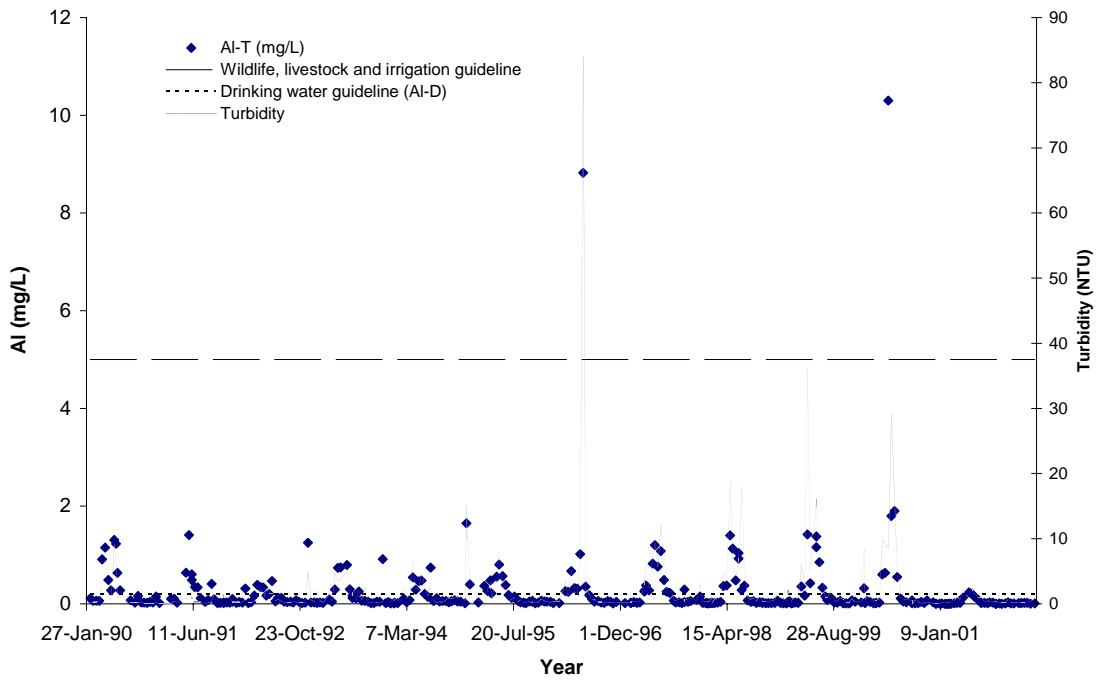
Figure 4. Kettle River at Carson - Aluminum, Total

Total aluminum concentrations often exceeded the aquatic life guideline of 0.1 mg/L dissolved aluminum (36% of 322 samples) as well as the drinking water guideline of 0.2 mg/L dissolved aluminum (28% of samples) (Figure 4). However, as the total fraction of aluminum was measured and the guidelines are expressed in terms of dissolved aluminum, an accurate assessment of attainment cannot be made. The wildlife, livestock and irrigation guideline of 5 mg/L was exceeded by two values, and the maximum recorded value was 10.3 mg/L on May 9, 2000. The strong correlation between total aluminum and turbidity (Figure 4) suggests that the majority of the aluminum was

associated with particulate matter and would therefore be unavailable to biota as well as removed by treatment for turbidity prior to consumption as drinking water.

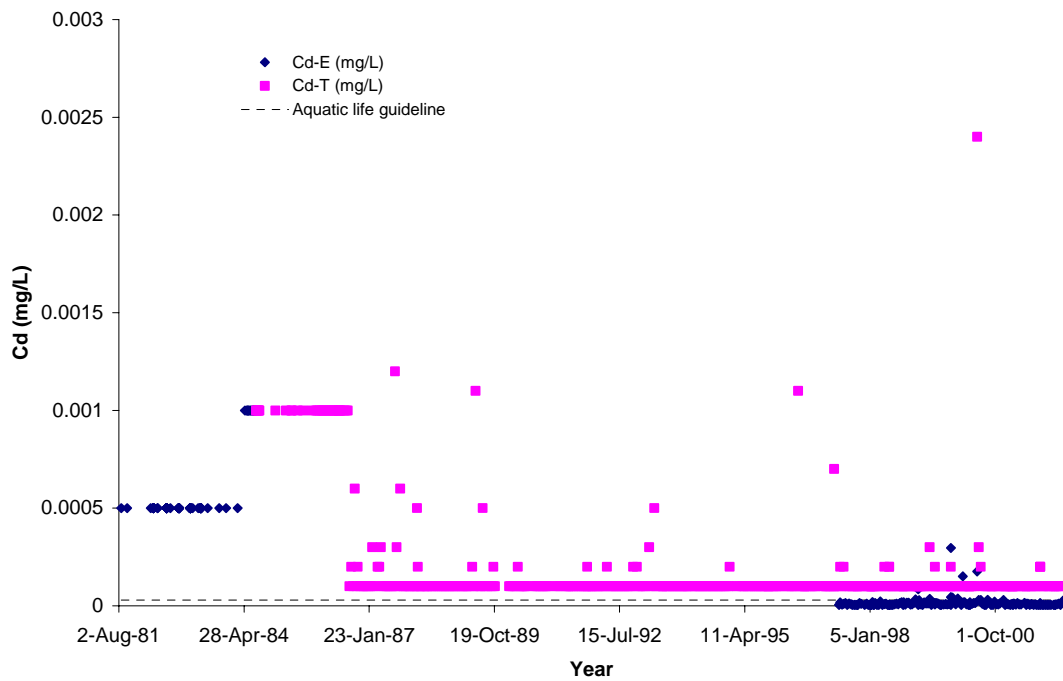
Figure 10. Kettle River at Carson - Cadmium, Total and Extractable

Total cadmium concentrations invariably appear to exceed the aquatic life guideline of 0.00003 mg/L (Figure 10), but this was due to the fact that the detection limits used in the analyses were between 30 and 300 times higher than the guideline limit. Ninety-one percent of the 461 samples collected between 1981 and 2002 were at or below their respective detection limits. Only 11 of 157 **extractable cadmium** concentrations measured between 1997 and 2002 exceeded the guideline of 0.00003 mg/L. In order to properly assess cadmium concentrations, it is essential that analytical methods with a detection limit of no more than one-tenth the guideline level be employed when such methods become available.

- The minimum detection limit used for cadmium analyses was much too high to determine guideline compliance. Tests with much lower analytical limits (maximum 1/10 the guideline, or 0.000003 mg/L) should be used when they become available.

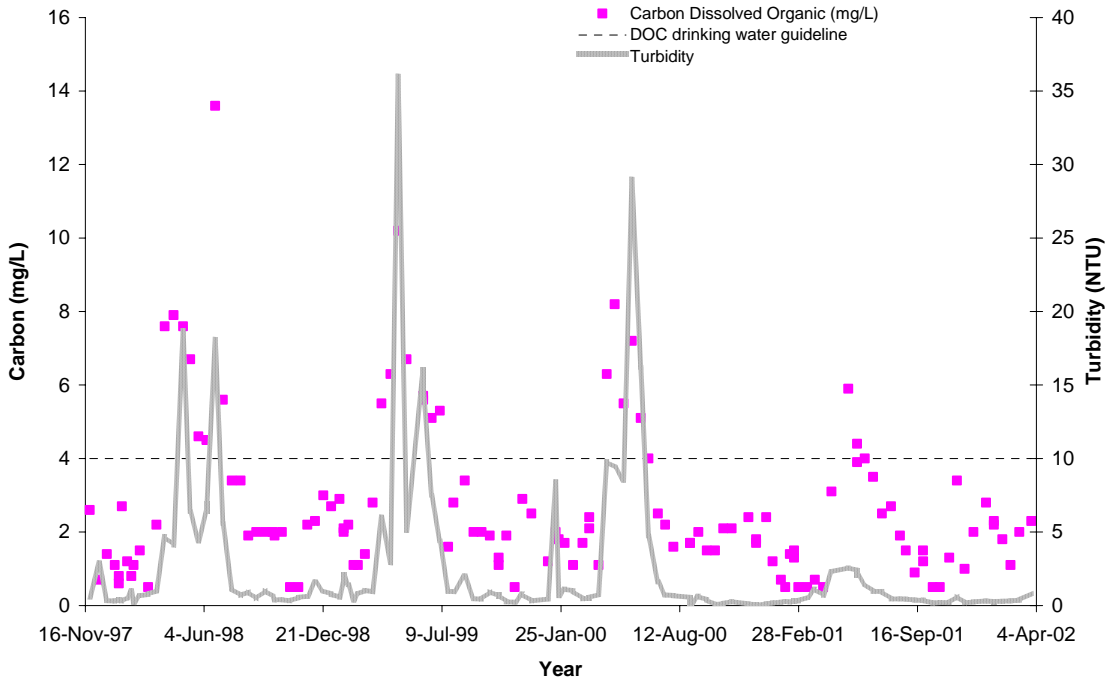
Figure 12. Kettle River at Carson - Carbon, Dissolved Organic

Dissolved organic carbon concentrations showed a strong seasonal trend, typically exceeding the drinking water guideline of 4 mg/L between about March and June of every year (Figure 12). The maximum value measured at this site was 13.6 mg/L on June 22, 1998.

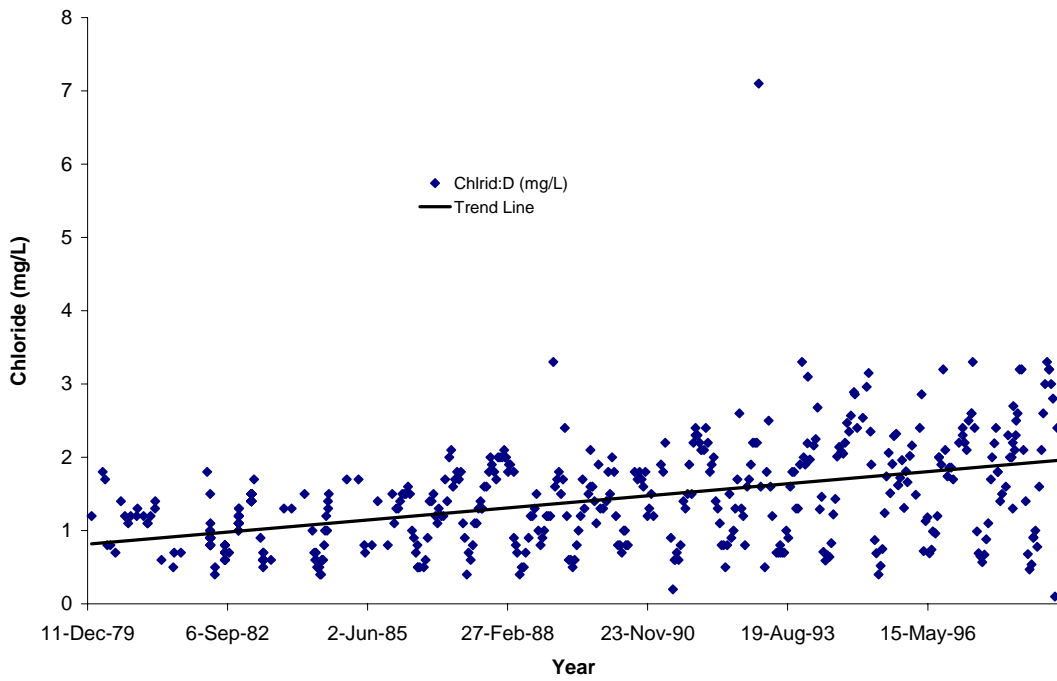
Figure 14. Kettle River at Carson - Chloride, Dissolved

Dissolved chloride concentrations may be increasing slightly in the Kettle River at Carson (Figure 14). There are no guidelines for this parameter, and it is not likely that this trend is cause for concern. It is likely that this apparent trend is a result of the change in methodology in mid-1991 from an automated colorimetric method to ion chromatography.

- Water temperatures frequently exceeded the general fisheries guideline.
- Dissolved chloride may be increasing slightly over time at this site. The cause for this increase is likely a change of analytical techniques with associated detection limits.

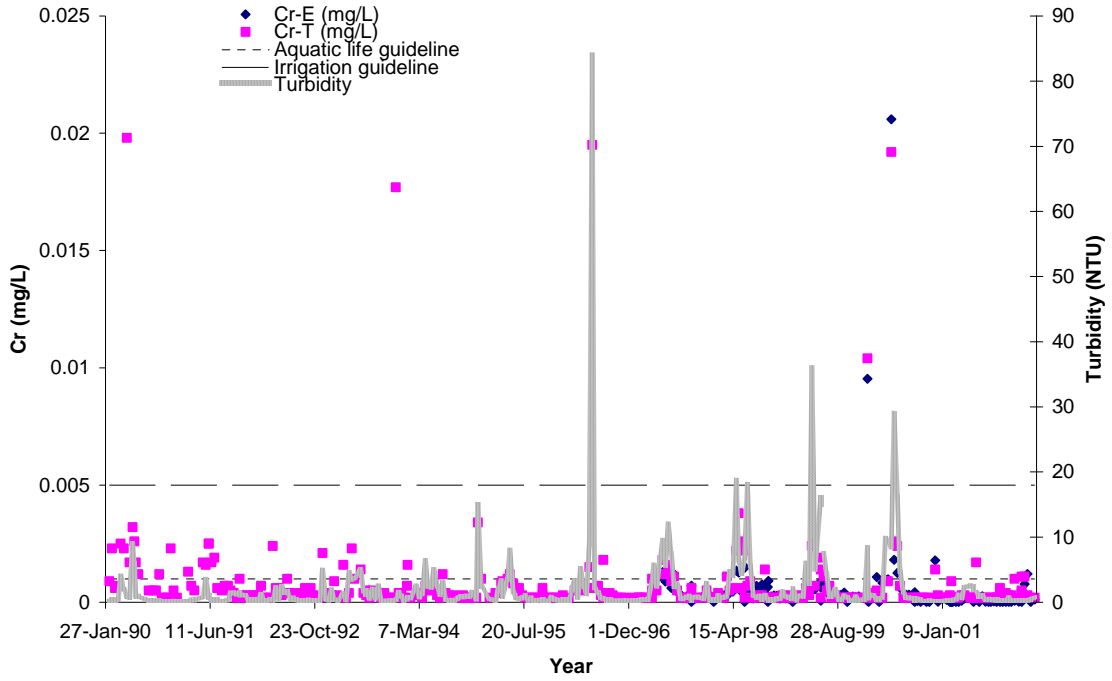
Figure 15. Kettle River at Carson - Chromium, Total and Extractable

Total chromium concentrations exceeded the aquatic life guideline of 0.001 mg/L on 54 occasions between 1990 and 2002 (16% of 341 samples), and exceeded the irrigation guideline of 0.005 mg/L on five occasions (1% of all samples) (Figure 15). There was a reasonably strong correlation between total chromium and turbidity (correlation coefficient = 0.50, $p < 0.001$; see Figure 15), suggesting that the majority of the chromium present was associated with suspended particulate matter and therefore not biologically available. Extractable chromium concentrations were well correlated to total

chromium values. If irrigation water is not filtered prior to use, prolonged irrigation may result in an elevation of this metal in soils, although the low level of exceedences suggest that this is not likely.

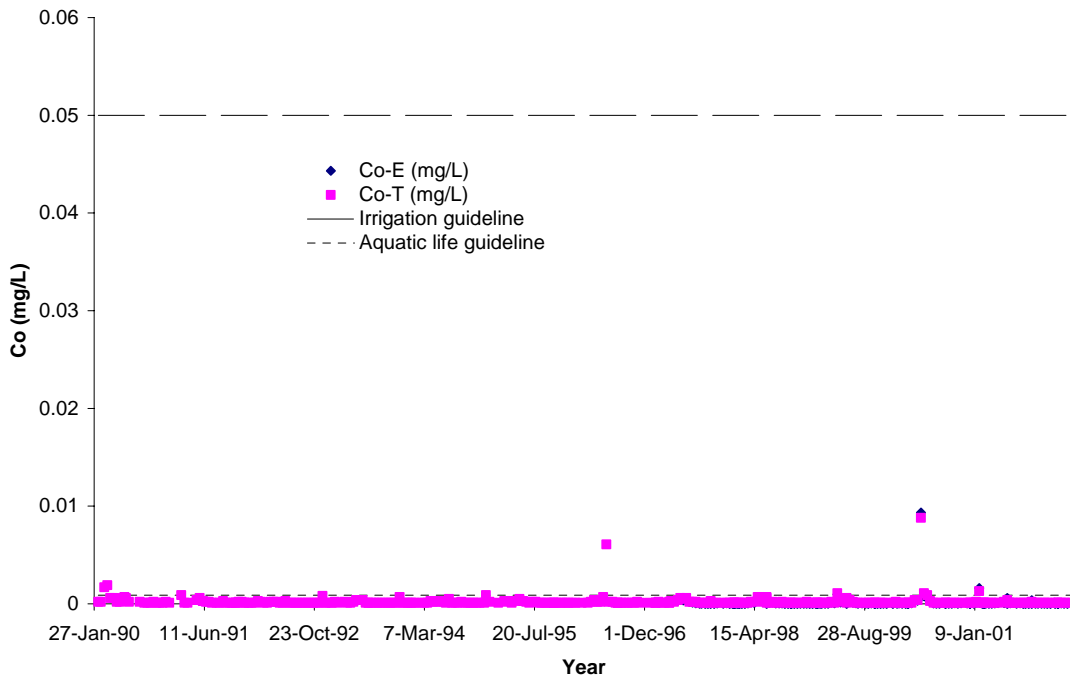
Figure 16. Kettle River at Carson - Cobalt, Total and Extractable

Total cobalt concentrations were generally low, with only seven values (2% of the 341 samples collected) having concentrations above the aquatic life guideline of 0.0009 mg/L (Figure 16). The maximum value (0.0088 mg/L) was well below the irrigation guideline of 0.05 mg/L.

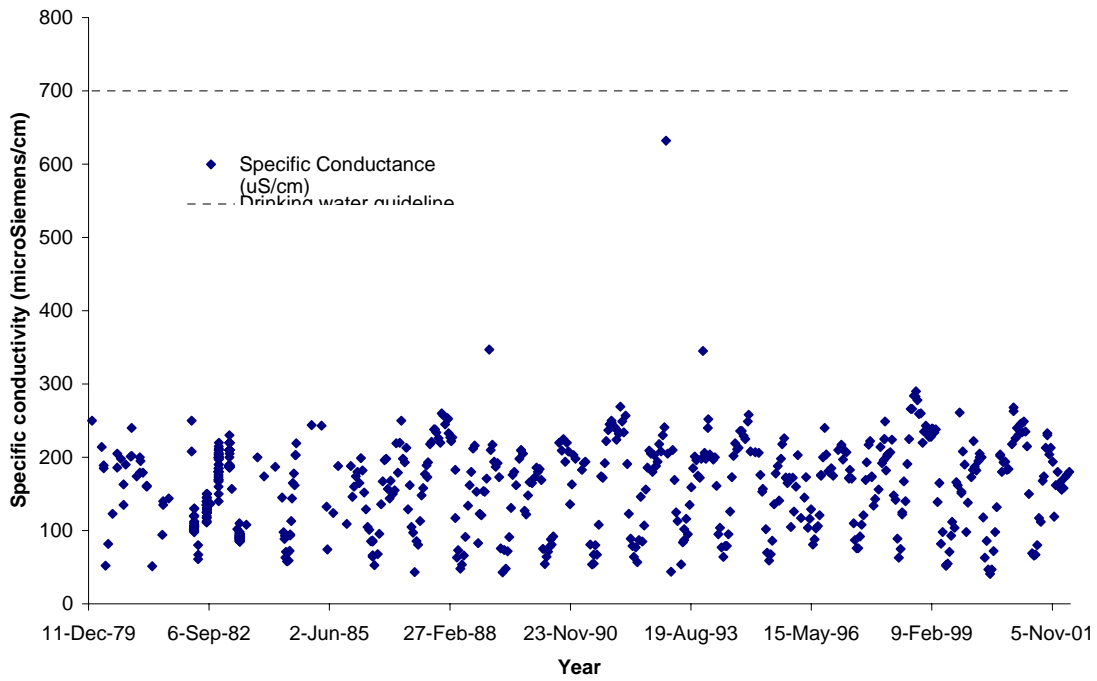
Figure 20. Kettle River at Carson - Conductivity, Specific

Specific conductivity values also varied seasonally, with maximum values during winter (low-flow) and minimum values occurring during spring freshet (Figure 20). This reflects the influence of groundwater contributions to baseline flows. Values were generally between 50 and 250 $\mu\text{S}/\text{cm}$, and no values exceeded the drinking water guideline of 700 $\mu\text{S}/\text{cm}$.

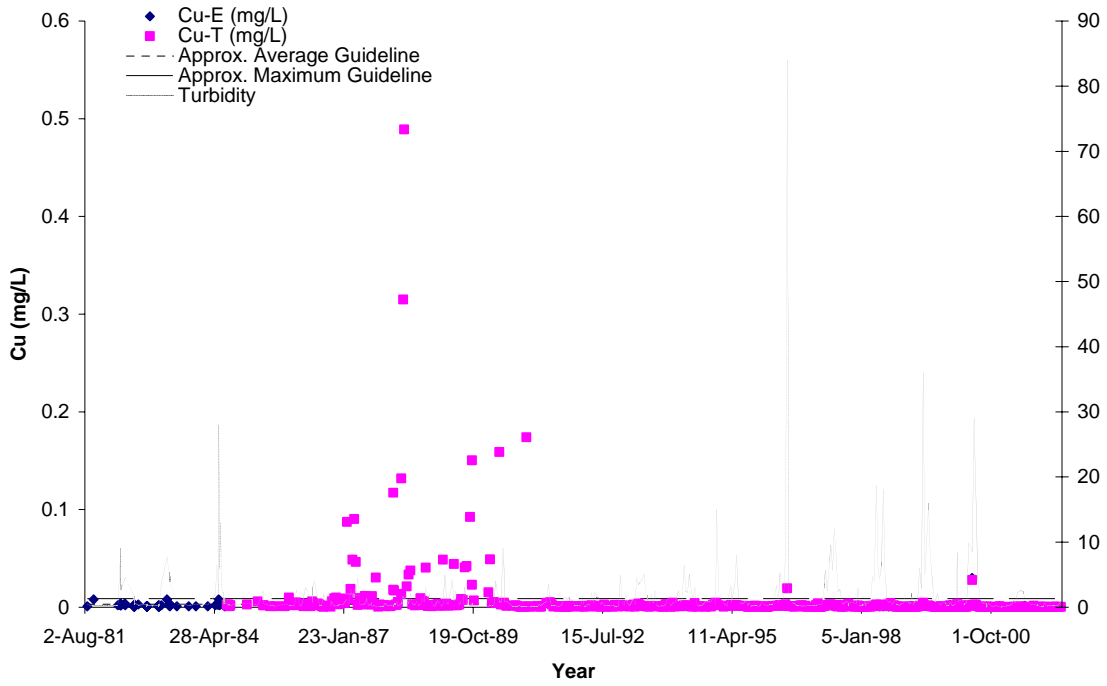
Figure 21. Kettle River at Carson - Copper, Total and Extractable

Total copper values measured between 1988 and 1991 were suspect due to preservative vial contamination (see Quality Assurance section, above). After this period, 31 values exceeded the hardness-dependent average total copper guideline, and seven values exceeded the maximum total copper guideline (Figure 21). These values were generally strongly correlated with turbidity values (see Figure 21), suggesting copper was associated with particulate matter and therefore not available to biota.

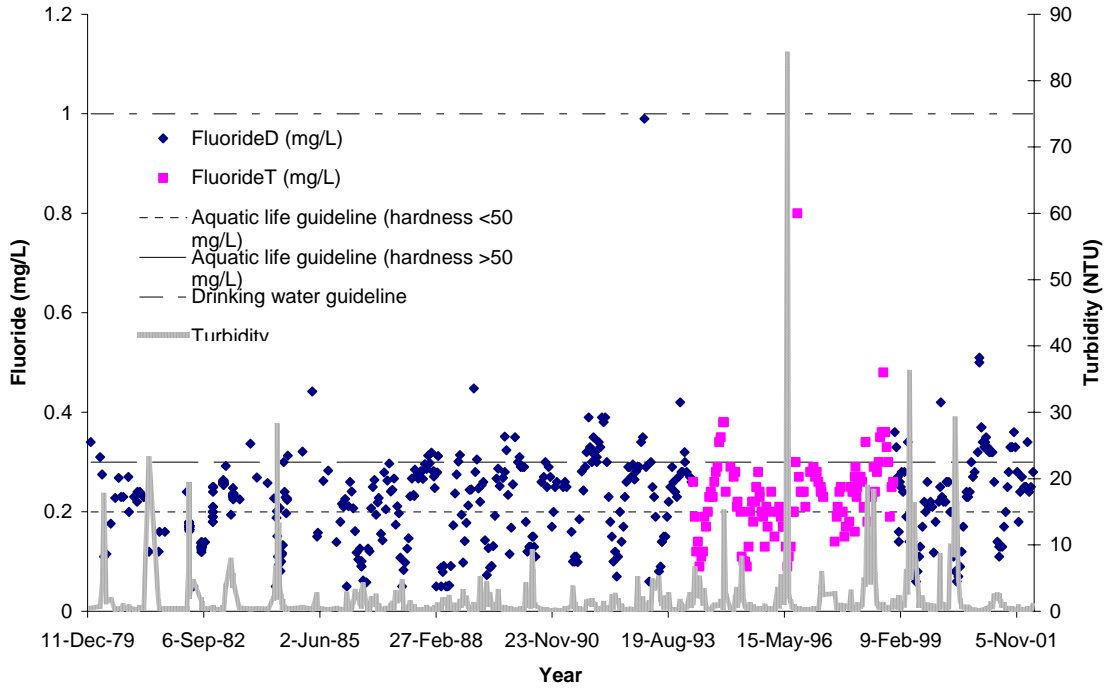
Figure 23. Kettle River at Carson - Fluoride, Total and Dissolved

Aquatic life guidelines for **total fluoride** are hardness dependent: at hardness < 50 mg/L, the guideline is a maximum of 0.2 mg/L fluoride, while at hardness 50 mg/L or higher, the guideline is 0.3 mg/L. Eighty-six values (15% of 582 values) exceeded the hardness-dependent guideline for total fluoride (Figure 23). Fluoride and turbidity are negatively correlated (correlation coefficient = -0.29, $p < 0.001$), suggesting that maximum fluoride concentrations occur during low-flow periods

- Concentrations of alkalinity and calcium indicate that the water is well buffered and has a low sensitivity to acid inputs.
- The water is naturally high in fluoride and exceeded guidelines for aquatic life on a few occasions. We are not aware of any effects on the local fish populations and expect that fish may be adapted to the higher levels of fluoride. There is no known anthropogenic source of fluoride in the watershed.

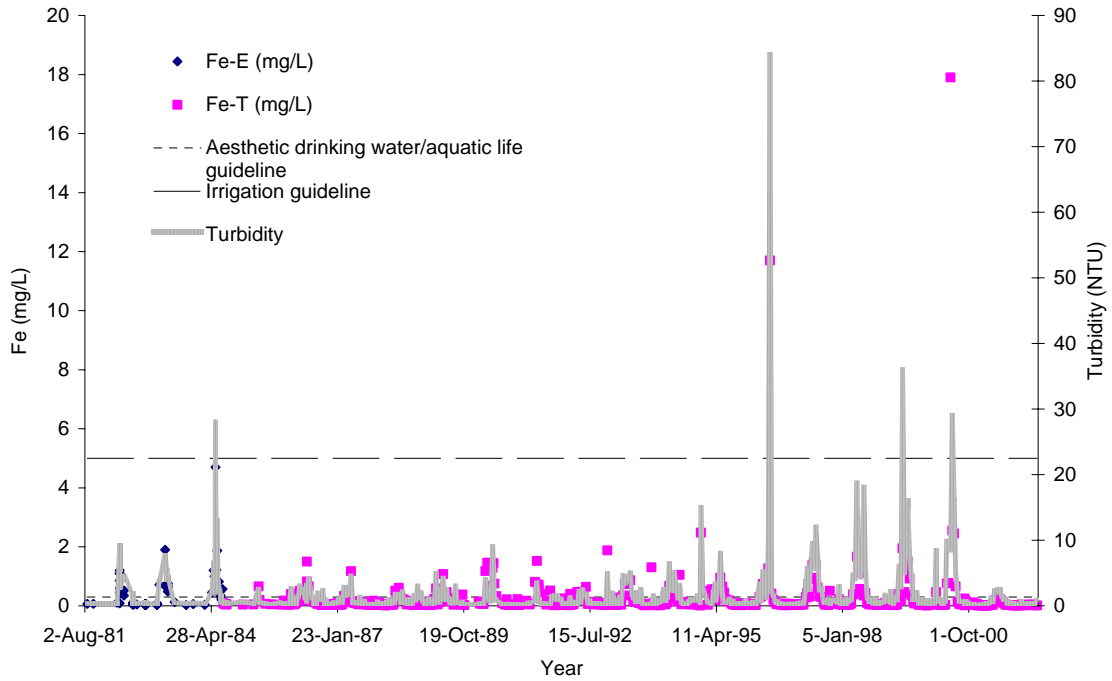
Figure 26. Kettle River at Carson - Iron, Total and Extractable

Total iron concentrations ranged from 0.0036 mg/L to 17.6 mg/L, with 101 values (23% of the 442 samples collected) exceeding the aquatic life guideline of 0.3 mg/L (Figure

26). These exceedences typically occurred during periods of elevated turbidity (see Figure 24), suggesting that the iron would not be available to biota.

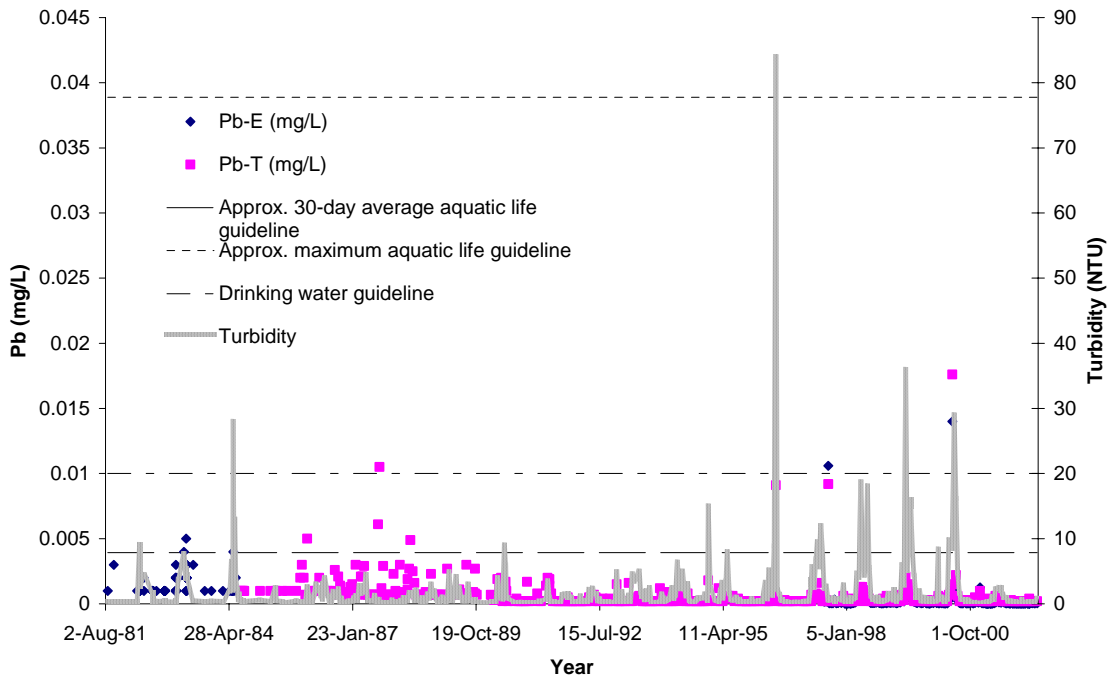
Figure 28. Kettle River at Carson - Lead, Total and Extractable

Total lead concentrations between 1988 and 1991 are suspect due to preservative vial contamination, and therefore will not be considered in this report. After 1991, three samples had total lead concentrations exceeding the hardness-dependent average guideline for the protection of aquatic life (Figure 28). As was typical for other metals, these exceedences showed a strong correlation with turbidity, suggesting that the lead was not toxic to aquatic life. No values exceeded the maximum aquatic life guideline.

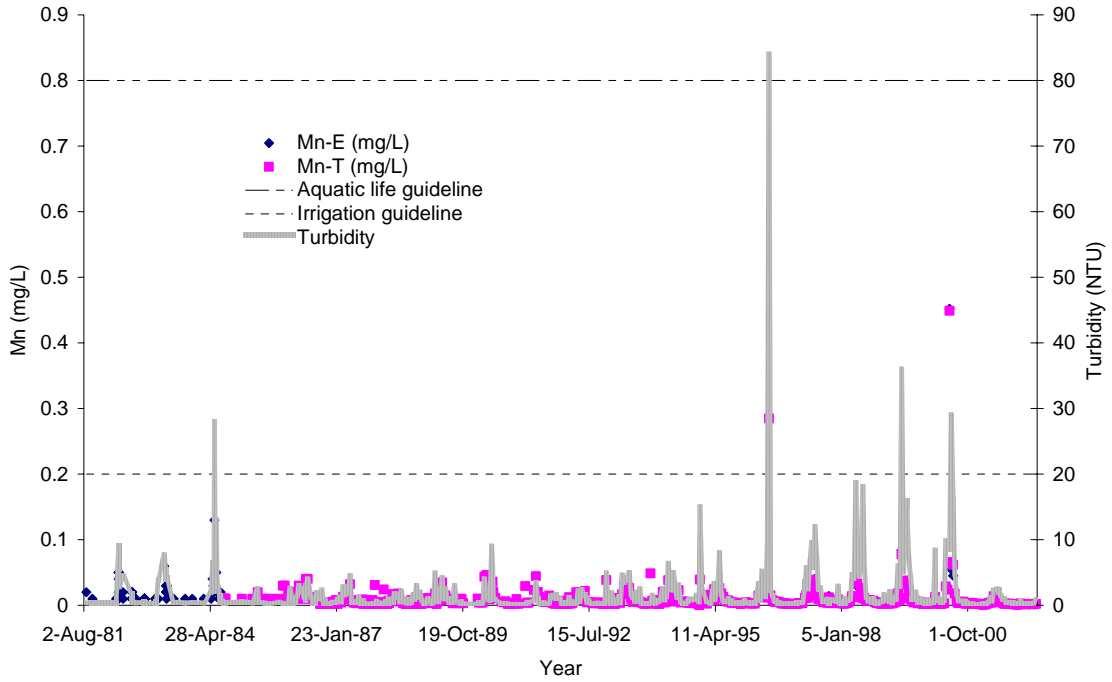
Figure 31. Kettle River at Carson - Manganese, Total and Extractable

Concentrations of **total manganese** ranged from 0.0002 mg/L to a maximum of 0.449 mg/L (Figure 30). Two samples had concentrations exceeding the irrigation guideline of 0.2 mg/L. Total manganese and turbidity concentrations were strongly correlated (correlation coefficient = 0.61, $p < 0.001$), suggesting that elevated levels of manganese were associated with particulate matter.

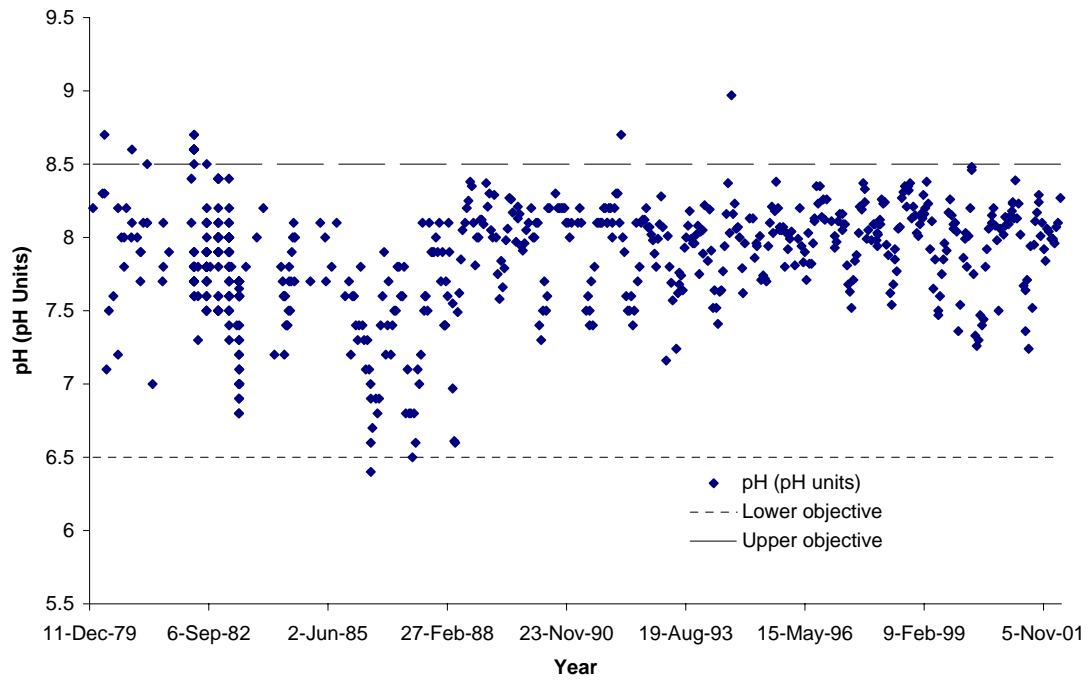
Figure 36. Kettle River at Carson - pH

pH values were generally within the acceptable drinking water range (between 6.5 and 8.5 pH units) over the period of record (Figure 36). Exceptions were one value below 6.5 (6.4, on May 26, 1986), but this was likely due to problems with control in the laboratory, and six values above 8.5 which are not likely a cause for concern. All of these excursions were measured before 1995. The highest recorded pH value was 8.97, on September 6, 1994.

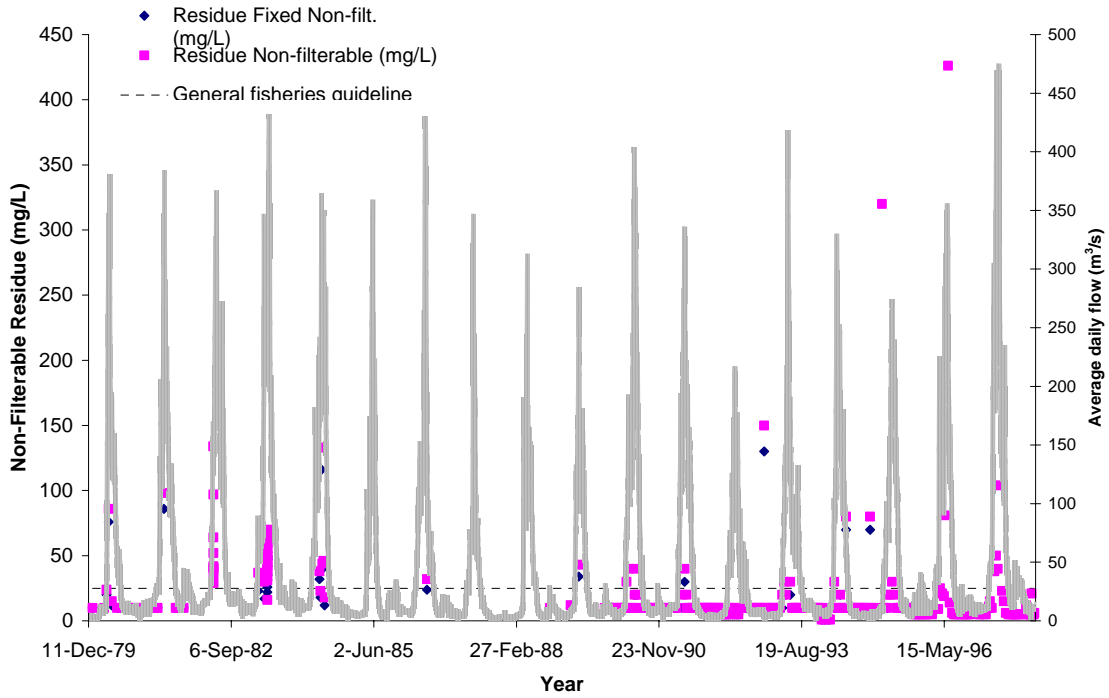
Figure 40. Kettle River at Carson - Residue, Non-Filterable

Concentrations of **non-filterable residue** (total suspended solids) ranged from below detectable limits (< 5 mg/L) to a maximum of 426 mg/L on June 10, 1996 (Figure 40). Non-filterable residue values showed a strong seasonal trend, with peak values occurring during the spring freshet (correlation coefficient between NFR and flow = 0.44, $p < 0.001$). Fifty-four values (20% of the 269 samples collected between 1980 and 2002) exceeded the general fisheries guideline of 25 mg/L.

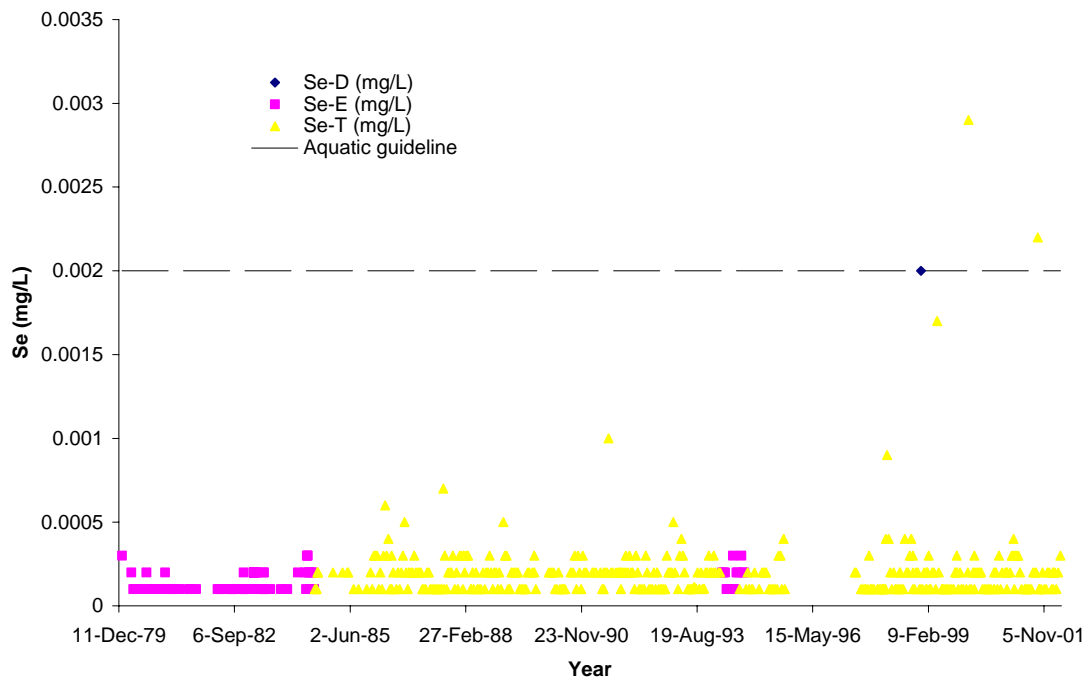
Figure 42. Kettle River at Carson - Selenium, Total, Dissolved and Extractable

Total selenium concentrations were generally low, with most values near the detection limit of 0.0001 mg/L (Figure 42). The exception to this were two values occurring in 2000 and 2001 of 0.0022 mg/L and 0.0029 mg/L, slightly exceeding the aquatic life guideline of 0.002 mg/L.

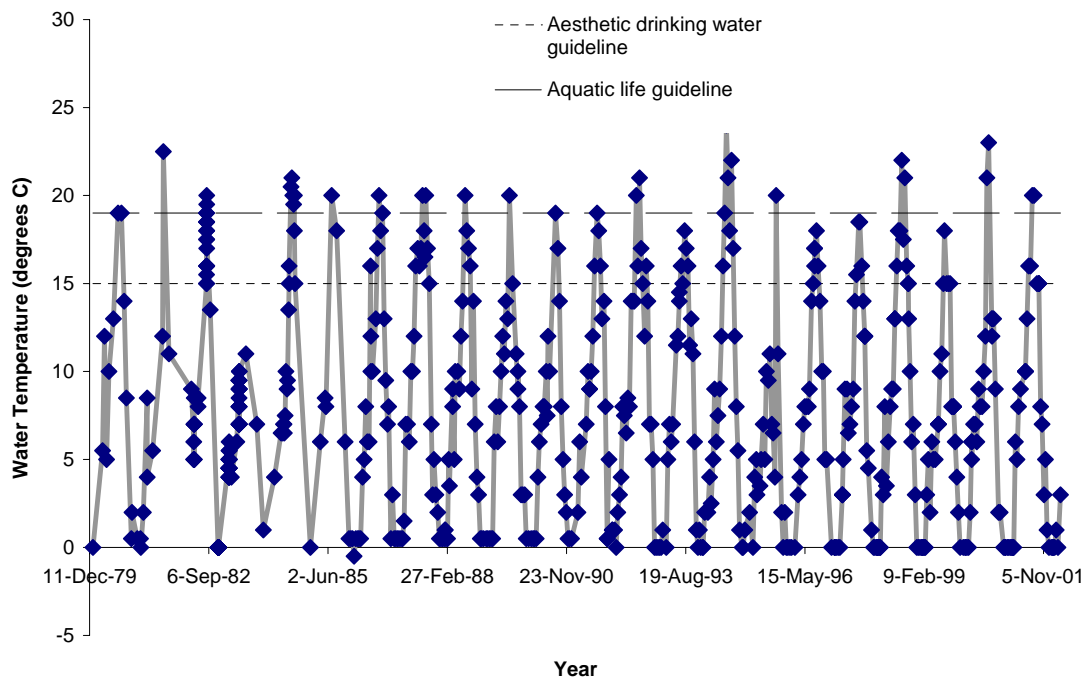
Figure 48. Kettle River at Carson - Temperature, Water

Water temperatures in the Kettle River at Carson exceeded the aesthetic drinking water guideline (15°C) almost every summer between 1980 and 2002. During most summers, the general fisheries guideline of 19°C was also exceeded (Figure 48).

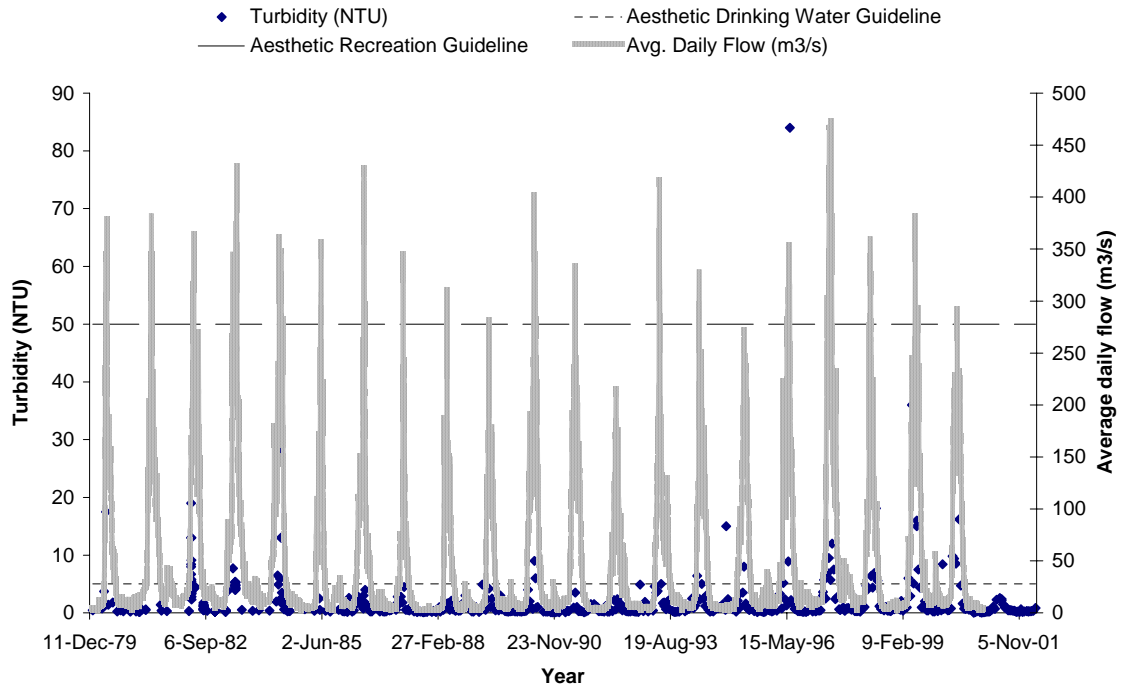
Figure 50. Kettle River at Carson - Turbidity and Flow

As expected, **turbidity** values followed a trend similar to that of non-filterable residue, with maximum values occurring during the spring freshet (Figure 50). One value (84 NTU, on June 4, 1986) exceeded the aesthetic recreation guideline of 50 NTU. There was a good positive correlation between turbidity and flow (correlation coefficient = 0.56, $p < 0.001$).

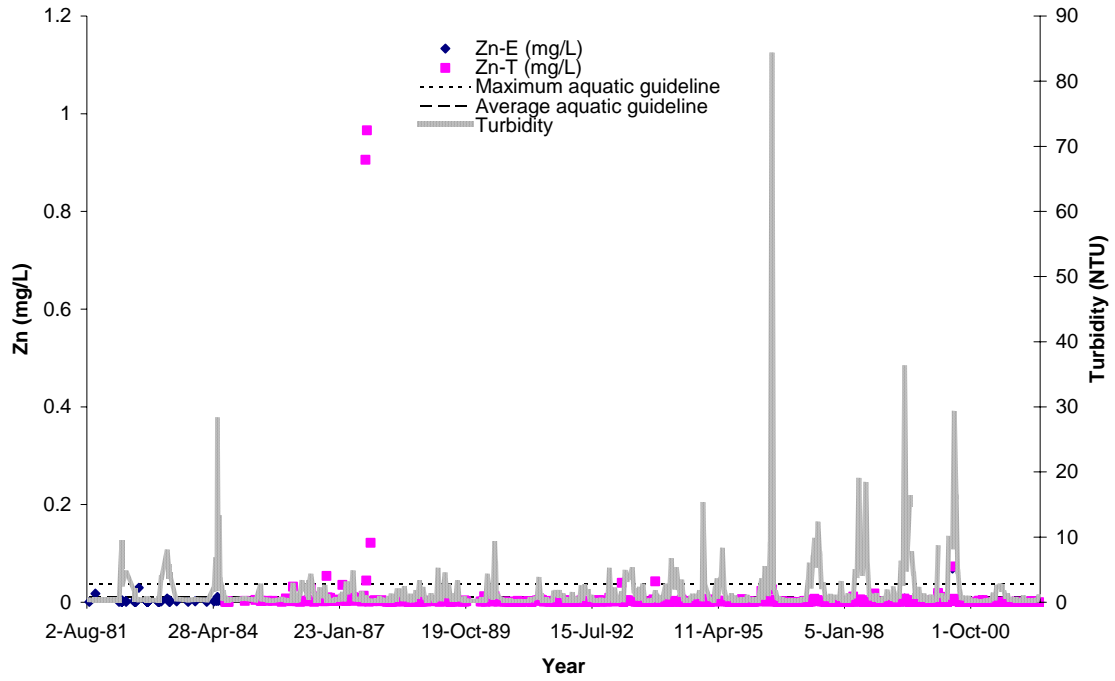
Figure 53. Kettle River at Carson - Zinc, Total and Extractable

Five hundred and two samples were analyzed for **total zinc** concentrations between 1981 and 2002 (Figure 53). Of these, 30 (7%) individual values exceeded the hardness-dependent average aquatic life guideline and seven values (2%) exceeded the maximum aquatic life guideline. Total zinc concentrations were not well-correlated with turbidity (correlation coefficient = 0.00, $p = 0.96$) (Figure 51), and so the bio-availability of the zinc is unknown.
