WATER QUALITY MONITORING AGREEMENT

WATER QUALITY ASSESSMENT OF KOKSILAH RIVER AT HIGHWAY 1 BRIDGE (1971 – 2003)

Pommen Water Quality Consulting

November 2004

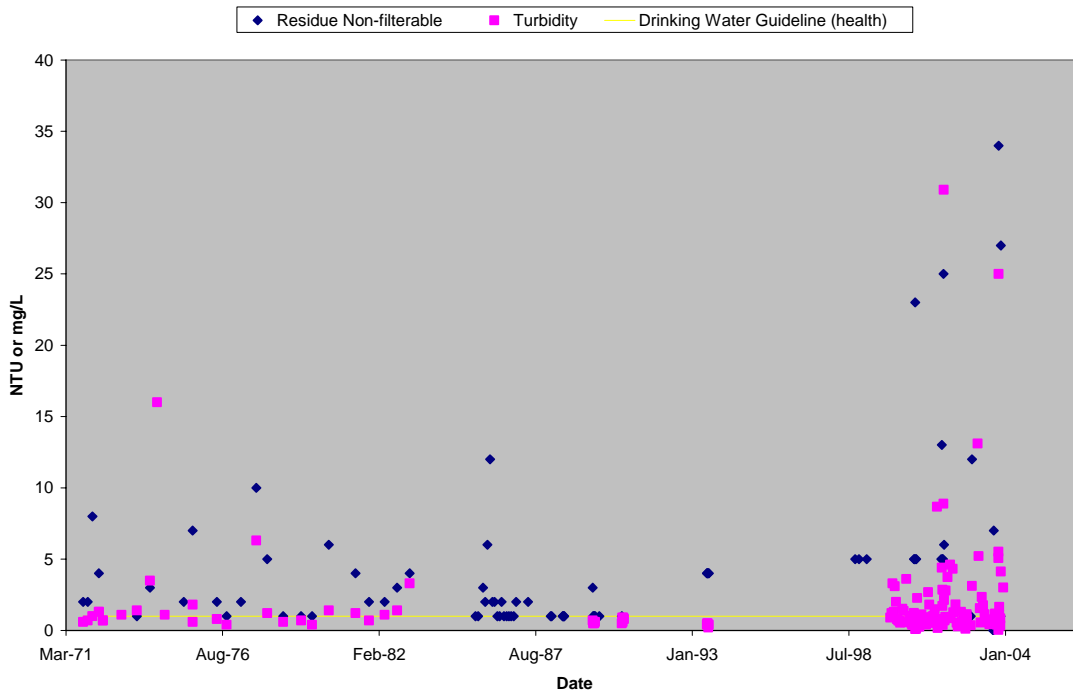
Figure 14 Turbidity and Residue, Non-filterable

Turbidity and Residue, non-filterable – Figure 18 – shows higher values for non-filterable residue and turbidity during fall-winter high flows, which is normal. Turbidity

had 38% (62 of 165) values above the drinking water health guideline of 1 NTU, indicating that partial treatment (e.g., filtration) plus disinfection would be needed before drinking water use. There is an apparent increasing trend over time, but this is due to differences in sampling frequency during 1971-99 (average of <3 samples/year) and 2000-03 (average of 32 samples/year). Twenty-eight winter (October-March) results were collected during 1971-99, compared to 71 winter results during 2000-03. The regular (biweekly) and more frequent sampling during 2000-03 resulted in the sampling of more of the winter high flow events, which have high non-filterable residue and turbidity.
