**Forest
Practices
Board**

Harvest Planning and Practices in the Hunaker Creek Watershed

Complaint Investigation #121022

January 2014

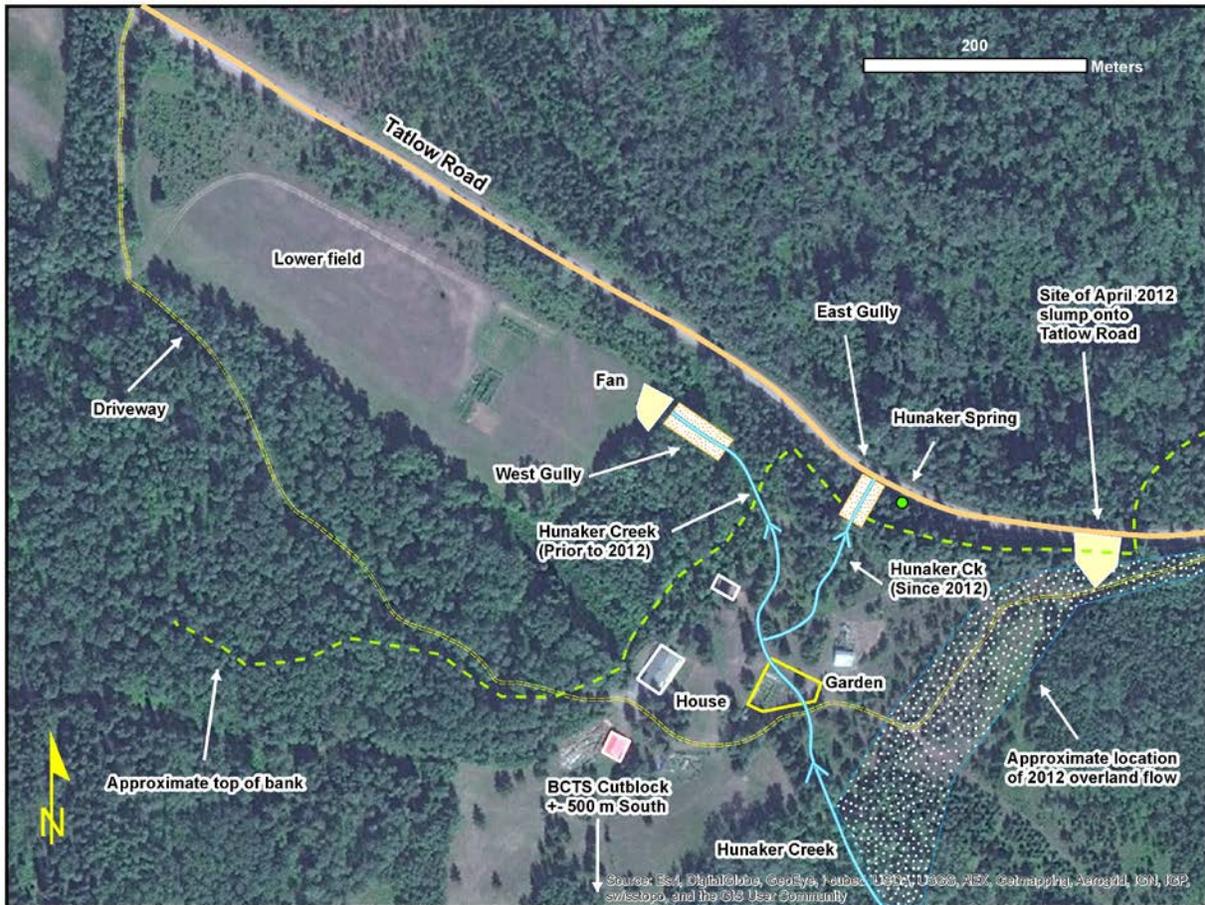
In about 1990, a previous owner of the property diverted the creek to lead it from the east gully to the west gully (Figure 2). The current owner says that when he took up residence in 2004, he saw no

erosion evident and high spring peak flows only started eroding the gully in 2009, leading to formation of a fresh alluvial fan in the lower field.

Figure 2. Site details.

Before the 2012 spring freshet, BCTS rerouted the stream to the location it was in prior to the 1990 diversion, the east gully. Since this redirection back to the east channel, there has been no additional erosion in the west gully or soil deposition in the lower field.

A rare phenomenon occurred during the spring 2012 freshet. On April 14, water-logged snow acted like a dam, inhibiting water flow in Hunaker Creek and causing flooding and overland flow on the complainant's property. The pooled water flowed over the hillcrest in a new location—a slope above Tatlow Road—where it caused a minor landslide and washout, temporarily closing Tatlow Road. The location of the overland flow is shown on Figure 2.

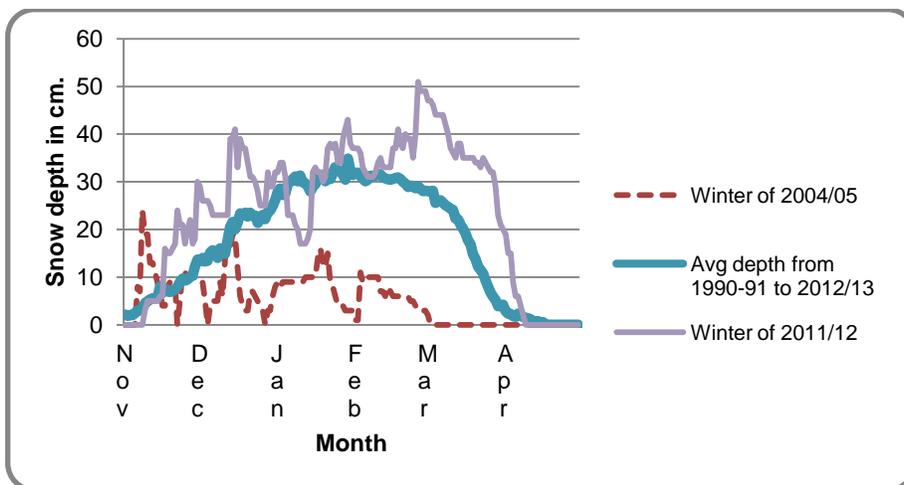
An examination of weather data from the Smithers airport reveals wide variation in snow accumulation and snowmelt patterns from year to year. For example, the spring freshet in 2012 was preceded by very high snow accumulation over the winter and rapid melt in the spring. This was a year with unusually high spring peak flows, including the rare overland flow event that subsequently washed out Tatlow Road. Conversely, the spring of 2004, observed by the complainant as a low peak flow year, had a low snow pack (Figure 3).

Not all of the peak flow events in Hunaker Creek conform to this pattern of high winter accumulation and rapid spring melt, but three of the four years with high peak flows reported by the complainant did have above average snowpack followed by rapid melt.

Figure 3. Daily snow depth measured at Smithers airport for a high peak flow year (2011/2012), a low peak flow year (2004/2005) and the 22 year average.

However, while this information suggests that above average snow accumulation combined with late and rapid snowmelt in the Smithers area likely contributed to the above normal peak flow levels on Hunaker Creek, a definitive conclusion on the role snow accumulation and melt has had on Hunaker Creek seasonal flow would require comprehensive records, such as snow water equivalency measurements near the site and objective measurements of flow rate in Hunaker Creek. The best information available for this investigation is limited to snow depth data from a site 14 kilometres away and memories of the nature of the flows since 2004 as recalled by the complainant.

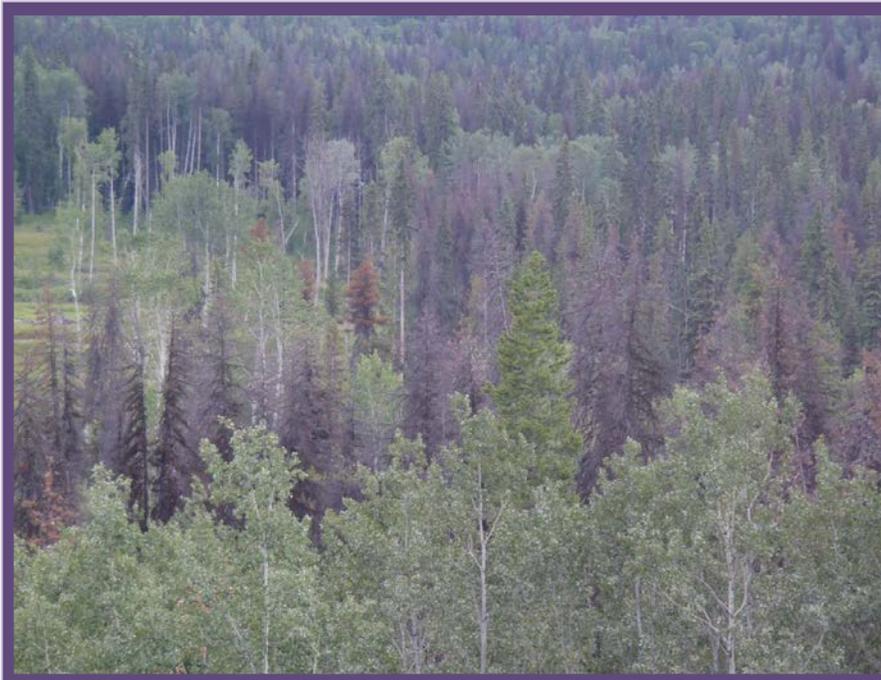
Deciduous stands, which comprise approximately 30 percent of the Hunaker Watershed area, typically have more rapid snow accumulation and melt than conifer stands, due to annual leaf fall resulting in an open winter canopy. As MPB affected lodgepole pine trees die and become defoliated, canopy closure is also reduced, resulting in more rapid snow accumulation and snowmelt.^{iv}

Figure 4. MPB affected forest near the BCTS cutblock, August 2012.

Recent research also indicates that affected pine cease to transpire (release water vapour) within weeks of being attacked by MPB.^v The resulting reduction in transpiration makes more water available for runoff and infiltration to groundwater.

MPB damage was clearly evident when the initial timber cruise was completed for the cutblock in 2007. At that time, lodgepole pine, which comprised 91 percent of the timber in the cutblock, was classified as 17 percent green attack (recently attacked) and 3 percent red and grey attack (older beetle attack). By early 2009, 50 percent or more of the lodgepole pine trees in the cutblock had been attacked by MPB.³ Board staff observed continued MPB activity in unlogged parts of the watershed during site visits in 2012 and 2013.

In the Hunaker Creek Watershed as a whole, approximately 70 percent of the forest had lodgepole pine as the leading species prior to the 2009 harvest. By 2009, all of the lodgepole pine stands within the watershed were affected by MPB. Because of this, transpiration rates for the forest as a whole would have slowed, and snow accumulation and snowmelt rates had likely increased, probably increasing runoff and peak flows.

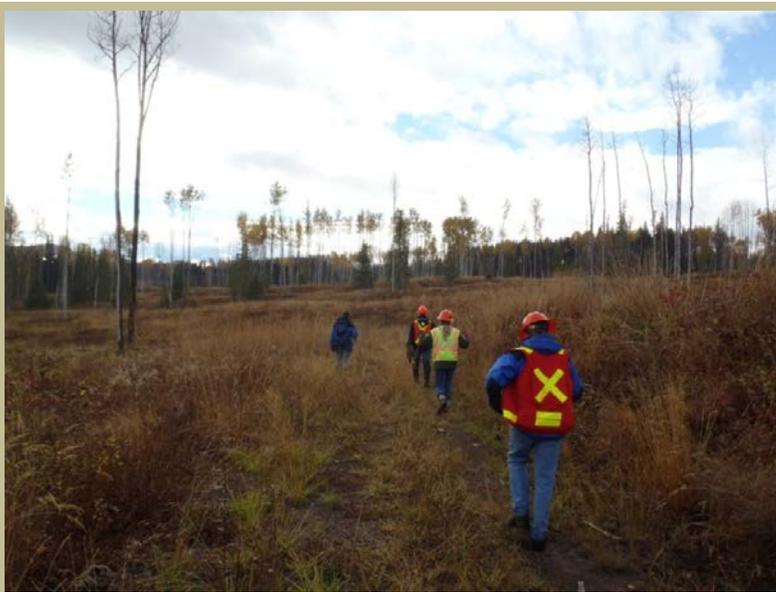
Figure 5. A deactivated road in the cutblock (October 2012). Note the retained deciduous trees and wildlife tree patches in the background.

Road construction and ditching can intercept and redirect both surface and subsurface drainage. Where interception and diversion is significant and flows are concentrated into unconditioned areas, the result can be accelerated rates of runoff. The hydrologist that BCTS engaged in planning the harvesting also worked with a geomorphologist to complete a deactivation plan for the roads. The deactivation work was planned to mitigate possible hydrological consequences of the road network.

The road network built to access the cutblock was not excessive and effects on natural drainage patterns were minimal, with any effects corrected through deactivation shortly after harvest.

Based on these observations, it is unlikely that forest road construction and deactivation had a measurable effect on peak flow timing or magnitude. Although the degree to which roads and harvesting contributed to the hydrological results is unclear, BCTS completed a thorough job of the technical aspects of planning and the practices were within industry norms.
