## **Motorcycles, Rare Frogs and Water Shrew Habitat at Kanaka Creek**

*Complaint Investigation 080824*

**FPB/IRC/147**

February 2009

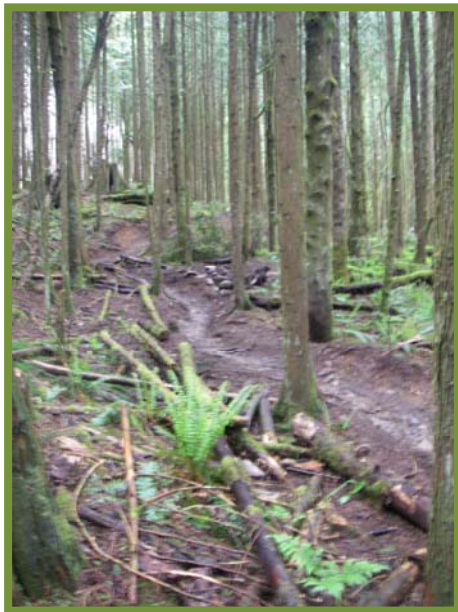
Trail with inadequate surface drainage.

The rutted condition of the trails, the damage to soil and the erosion into the creeks did not occur from a single use, but from repeated use. Furthermore, poor trail and crossing design along with a lack of cross-drainage on the trails, contributed to impacts. Subsequently, there have been trail improvements and footbridge construction to reduce further damage.

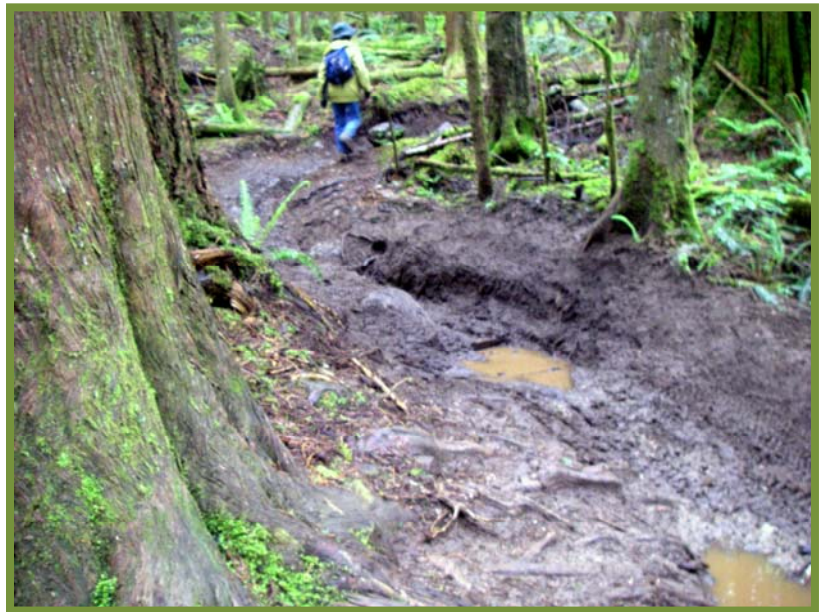
Soil disturbance, rutting, and water accumulating on trail.

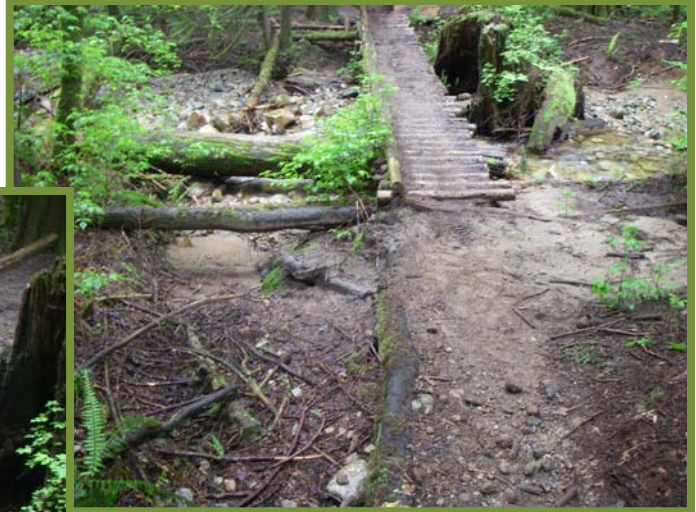
There is evidence that motorized vehicle use has damaged soil and introduced material to streams at the Kanaka Creek ford and at the Kathryn Creek crossing. Damaged soil and introduction of material into streams are events listed in section 3 of the FPPR, meeting the first of two elements of the regulation that define damage to the environment.

Trail approach to walkway introduces silt and soil to Kathryn Creek.

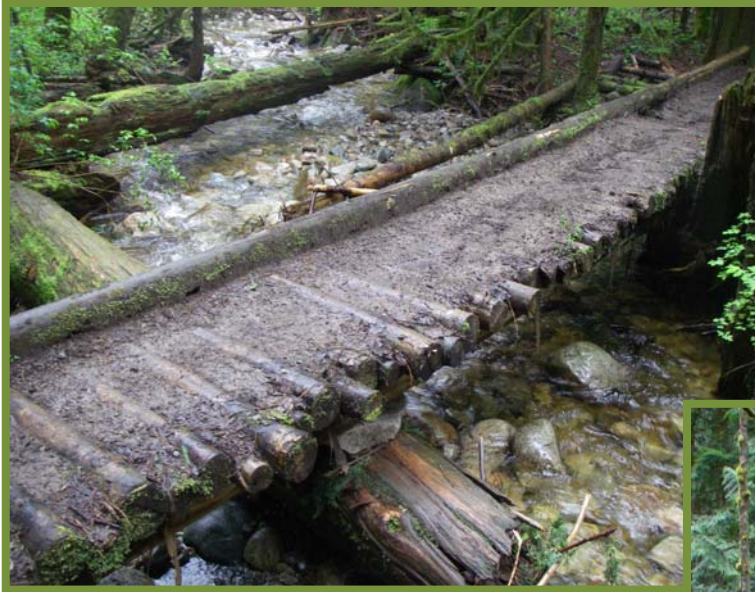
Accumulation of silt and soil on walkway over Kathryn Creek.

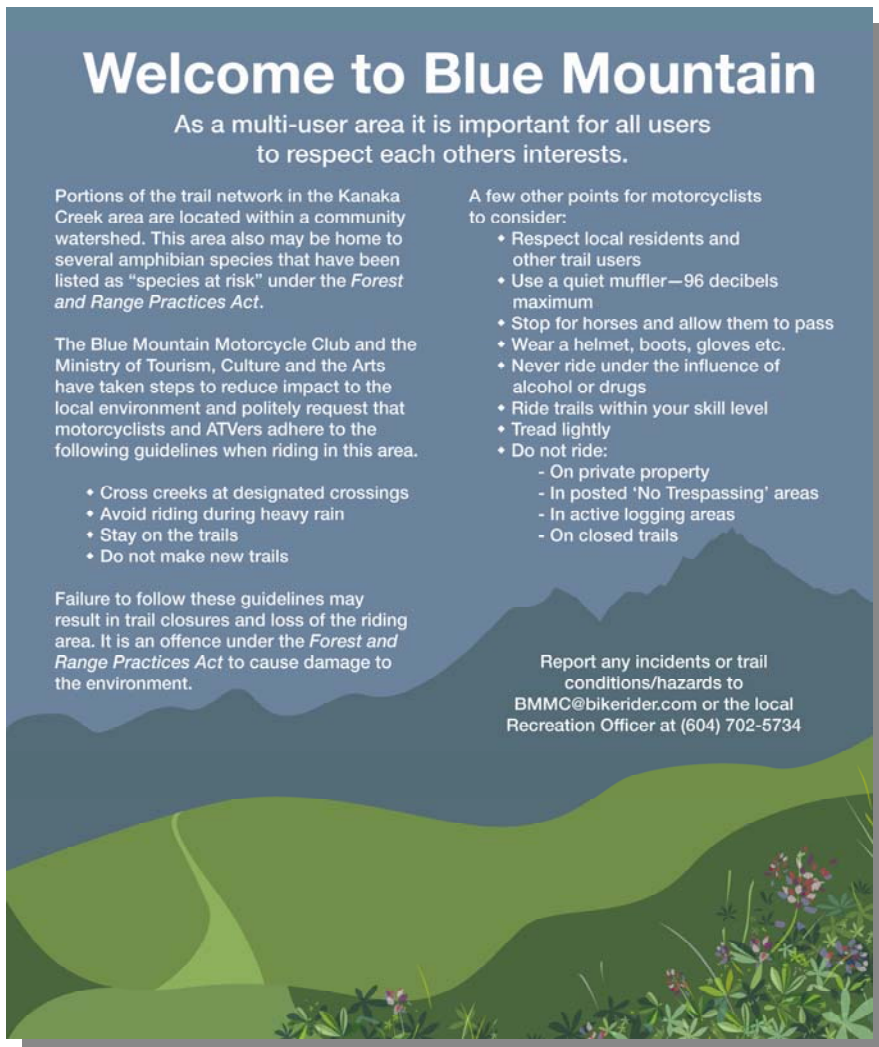
The complainants object to the sign because it refers to the motorcycle club. The objection is that, by including a reference to the motorcycle club, the sign may be interpreted as 'unofficial.' The complainants want signs indicating the authority of the provincial government. They also want the signs to clearly state that the Kathryn and Kanaka Creek watersheds are home to the Pacific tailed frog and red-legged frog, and are the source of the drinking water for the residents of Whonnock. The complainants say that such signs would be more persuasive in keeping motorcyclists out of sensitive areas.

The sign posted on the site provides advice, accurately references the legislation and states that the area is within a community watershed.

At a September 16, 2008, meeting with the complainants, MTCA said it was preparing information signs to: advise motorized users to keep to designated trails; describe the sensitive habitats and species; and describe consequences of damaging the environment from motorized vehicle use. MTCA says that if riders do not heed the signs, fail to stay on established trails and cause significant damage to the environment, the ministry could close the area to motorized vehicles.

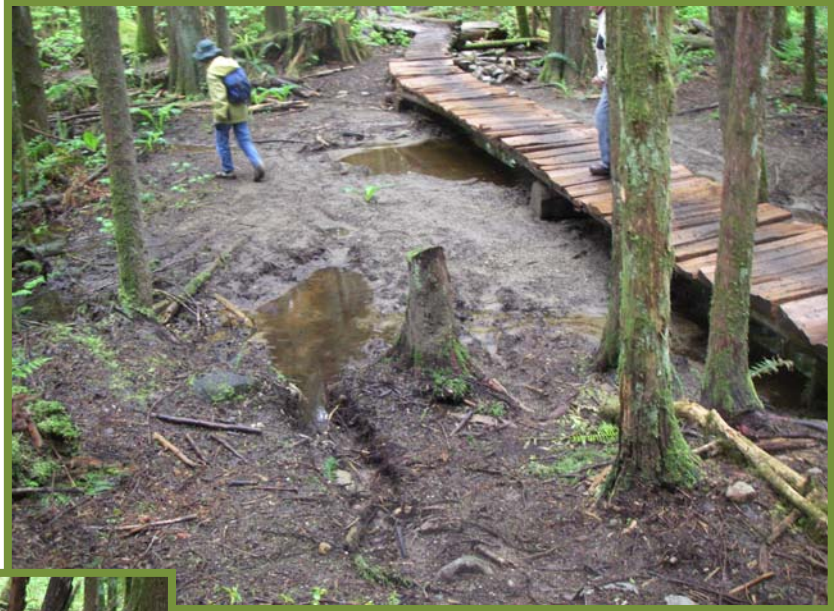
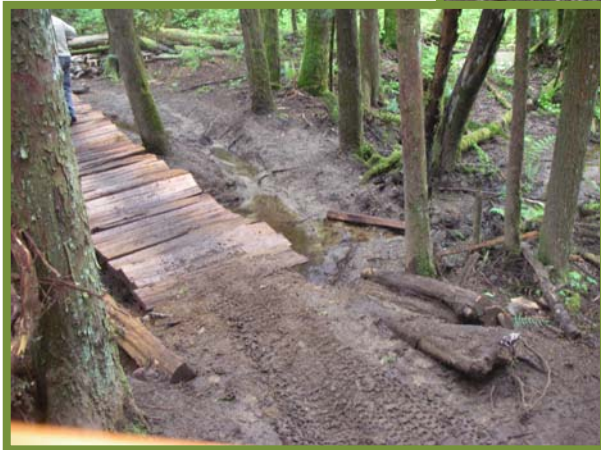
New boardwalk over wetland area with previous ATV or motorcycle impacts

In summary, MTCA is working collaboratively with a local motorcycle club to close poorly constructed or located trails, reconstruct bridges, build walkways and locate new trails.
