WATER QUALITY MONITORING AGREEMENT

WATER QUALITY ASSESSMENT OF FLATHEAD RIVER AT INTERNATIONAL BORDER (1980 – 2004)

Prepared by:
Pommen Water Quality Consulting

August 2005

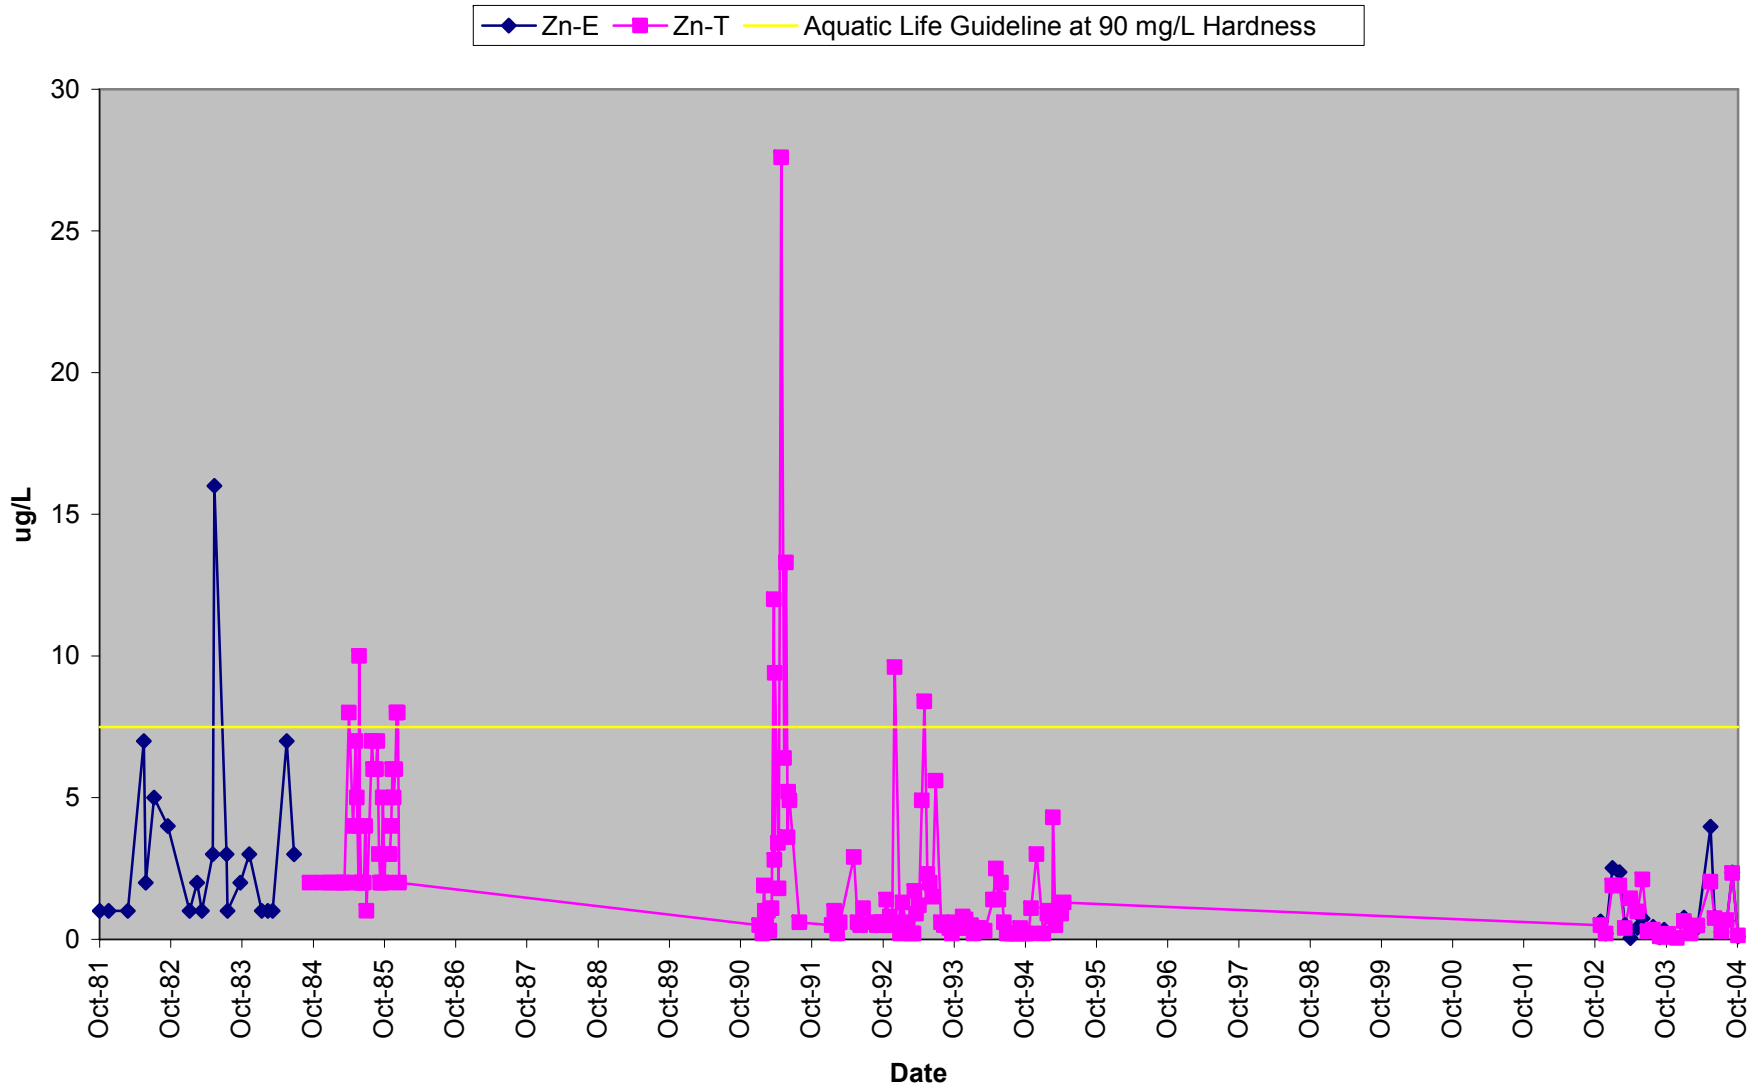
Figure 31a Zinc (Zn)

Zinc (Zn) (Figure 31a) shows high levels during 1984 due to a non-freshet outlier and in 1986-90 due to artificial contamination. These values were removed in **Figure 31b**, which shows several values above the lowest aquatic life guideline at 90 mg/L hardness, mainly during spring freshet, when turbidity was elevated. However, when the actual hardness is considered, only three values exceeded the guideline, all during freshet, in 1983 and 1991. There was an apparent declining trend over time, but this was due to declining MDL and the low turbidity in 2002-04.
