WATER QUALITY MONITORING AGREEMENT

WATER QUALITY ASSESSMENT OF Salmon River AT SALMON ARM (1985 – 2004)

Prepared by:
L. G. Swain, P. Eng.
B.C. Ministry of Environment

March 2007

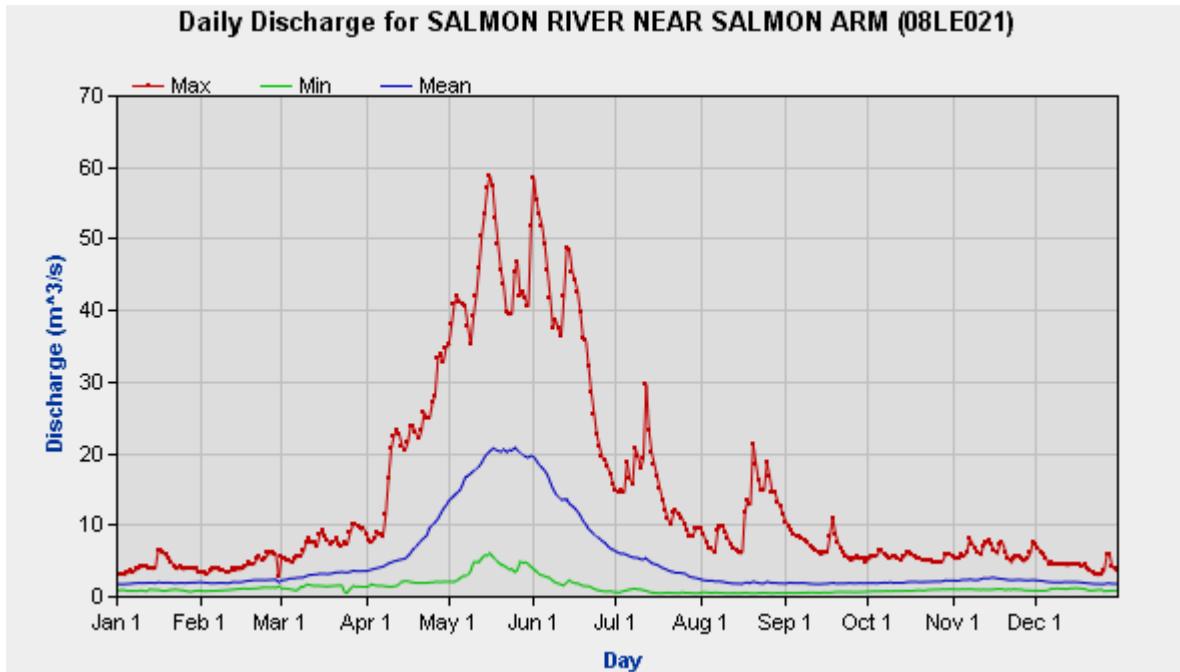
FIGURE 2: Water Survey of Canada Flow Data for Salmon River near Salmon Arm

Flows (Figure 2): fluctuate throughout the year, but peak in the May-June period on a yearly basis. Mean flows throughout the year are about 2 m³/s; although mean peak flows are about 20 m³/s. Absolute peak flows have been as high as 60 m³/s.

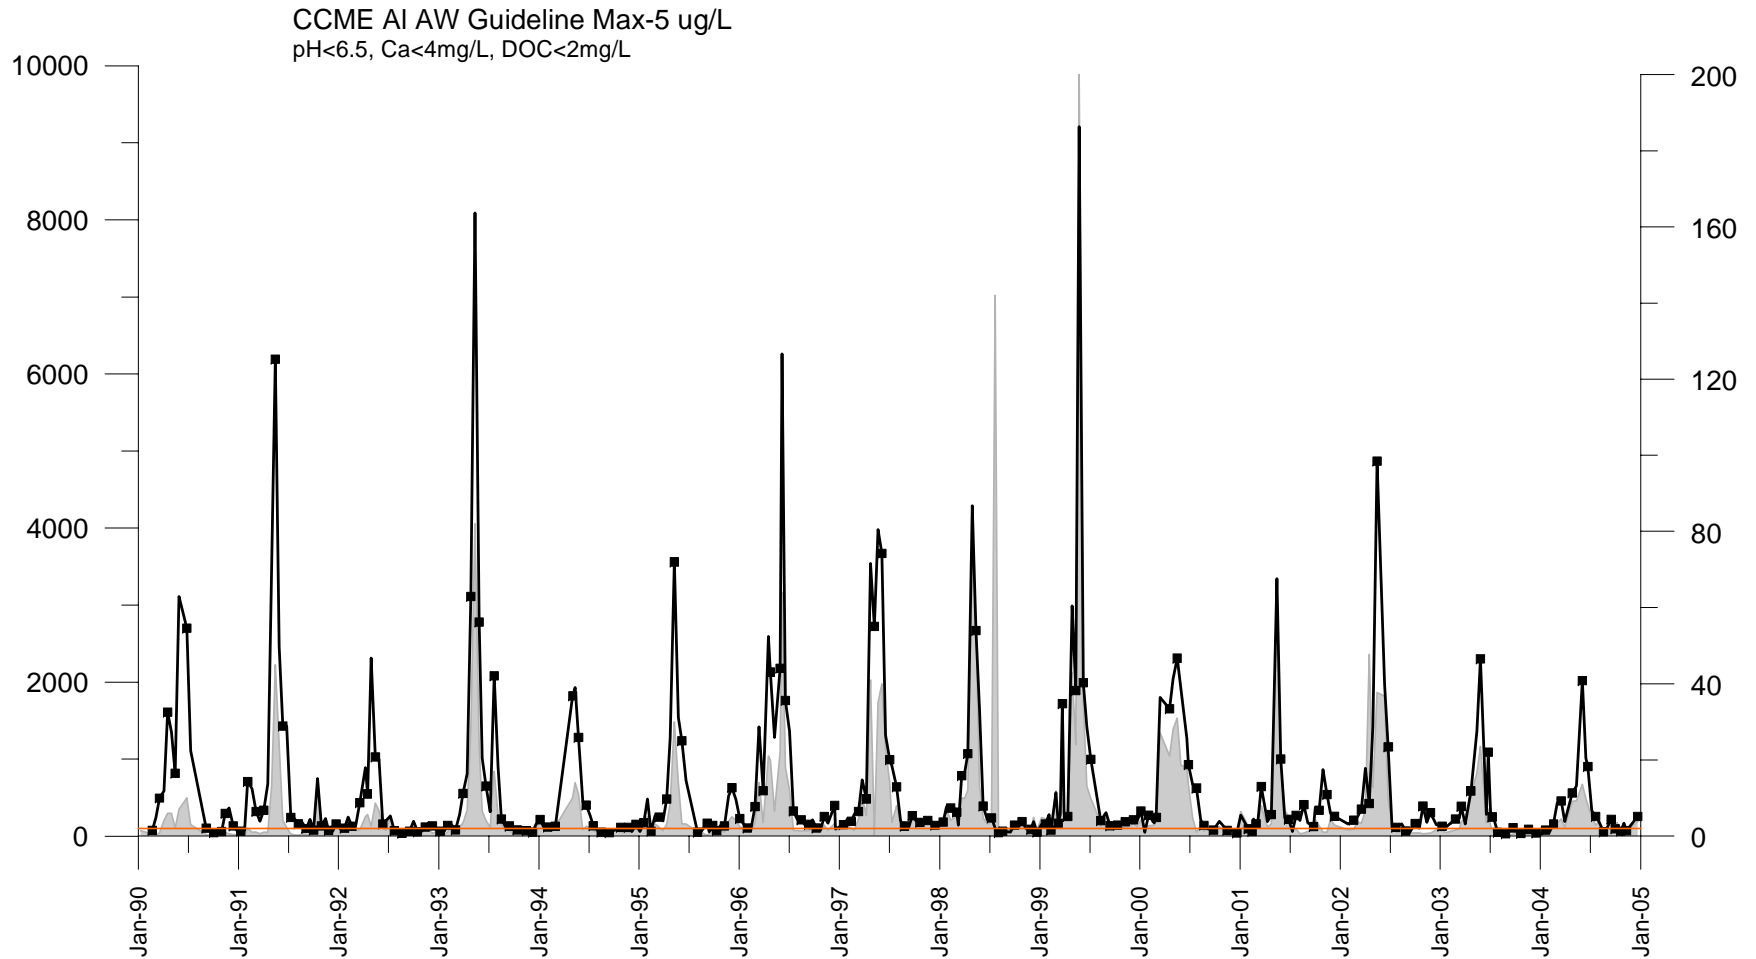
Salmon River at Hwy 1 Bridge Aluminum Total (ug/L) Figure 3

Aluminum (Figure 3): values exceed the drinking water guideline; however, values have fluctuated with turbidity, are likely in particulate form, and not biologically available. There does not appear to be any trend in values during the period of record.

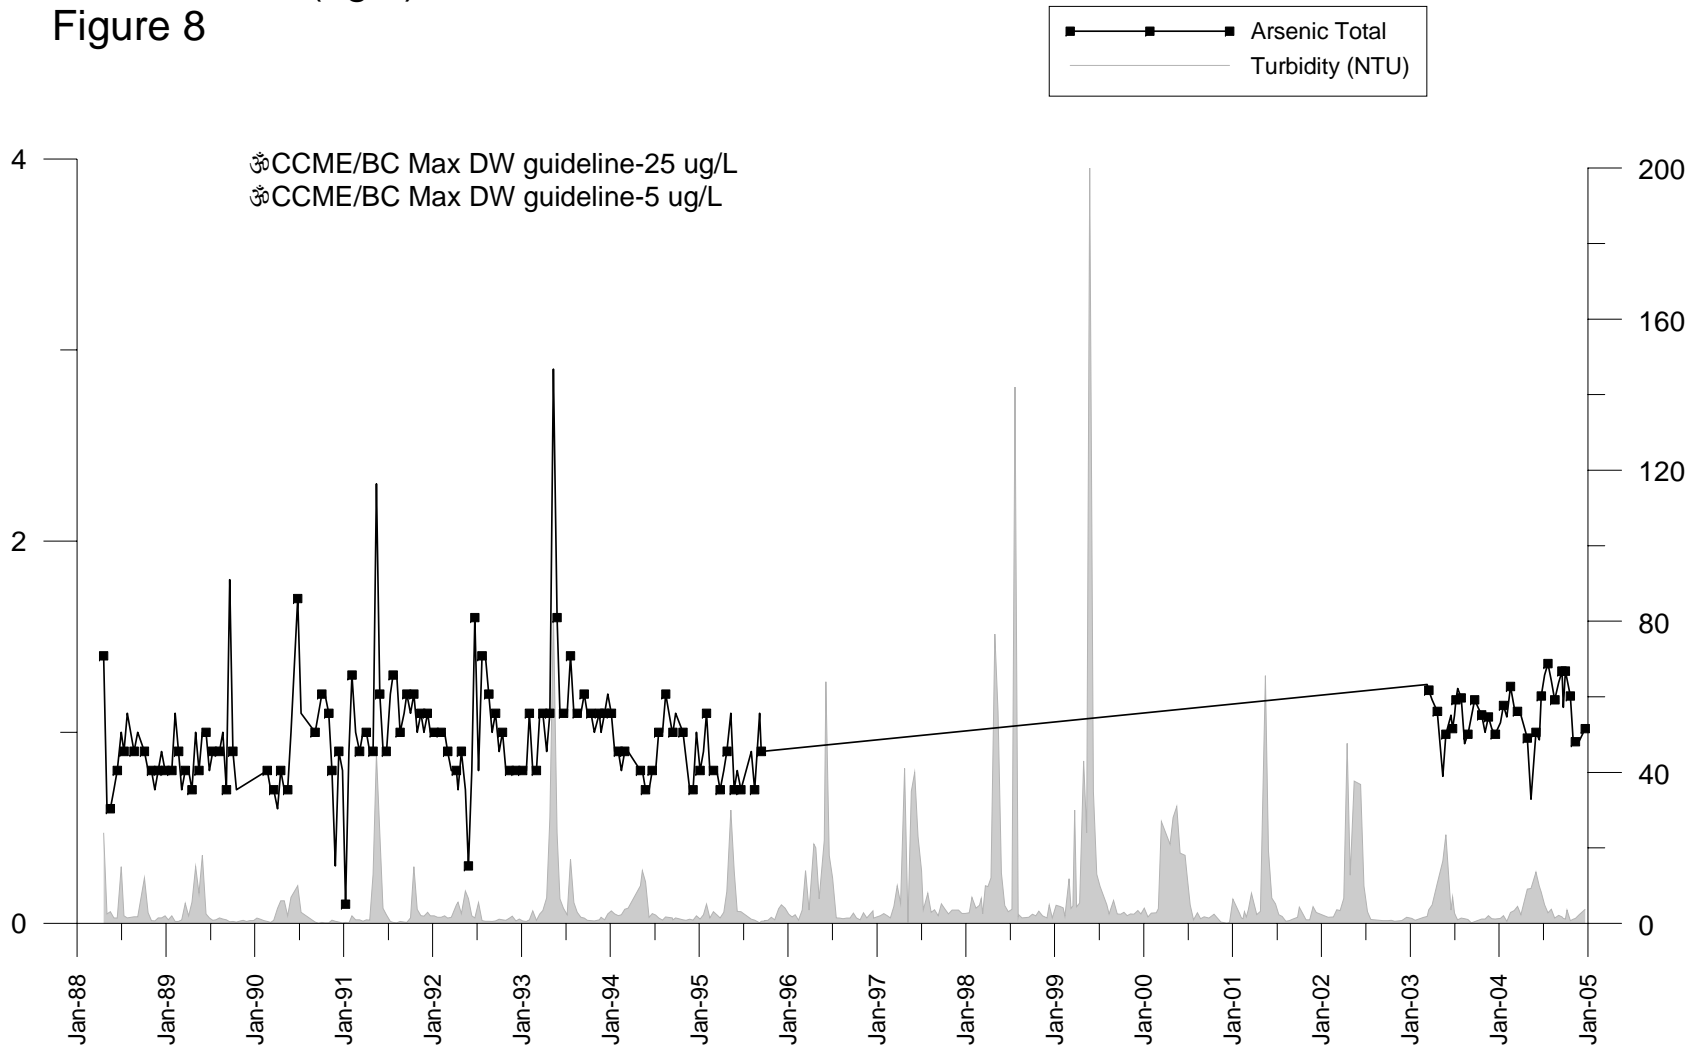
Figure 8

Arsenic (Figure 8): values have been below guidelines but seem to be increasing in value during the period of record. When we used a linear regression, we found that there was a weak correlation of values increasing through time ($R^2 = 0.05$). Total arsenic values also seem to increase with turbidity, meaning that higher values are likely in particulate form and not biologically available.

- Arsenic values may be showing a slight increase in concentration through the period of record. This may be due to a larger groundwater contribution to the flow.

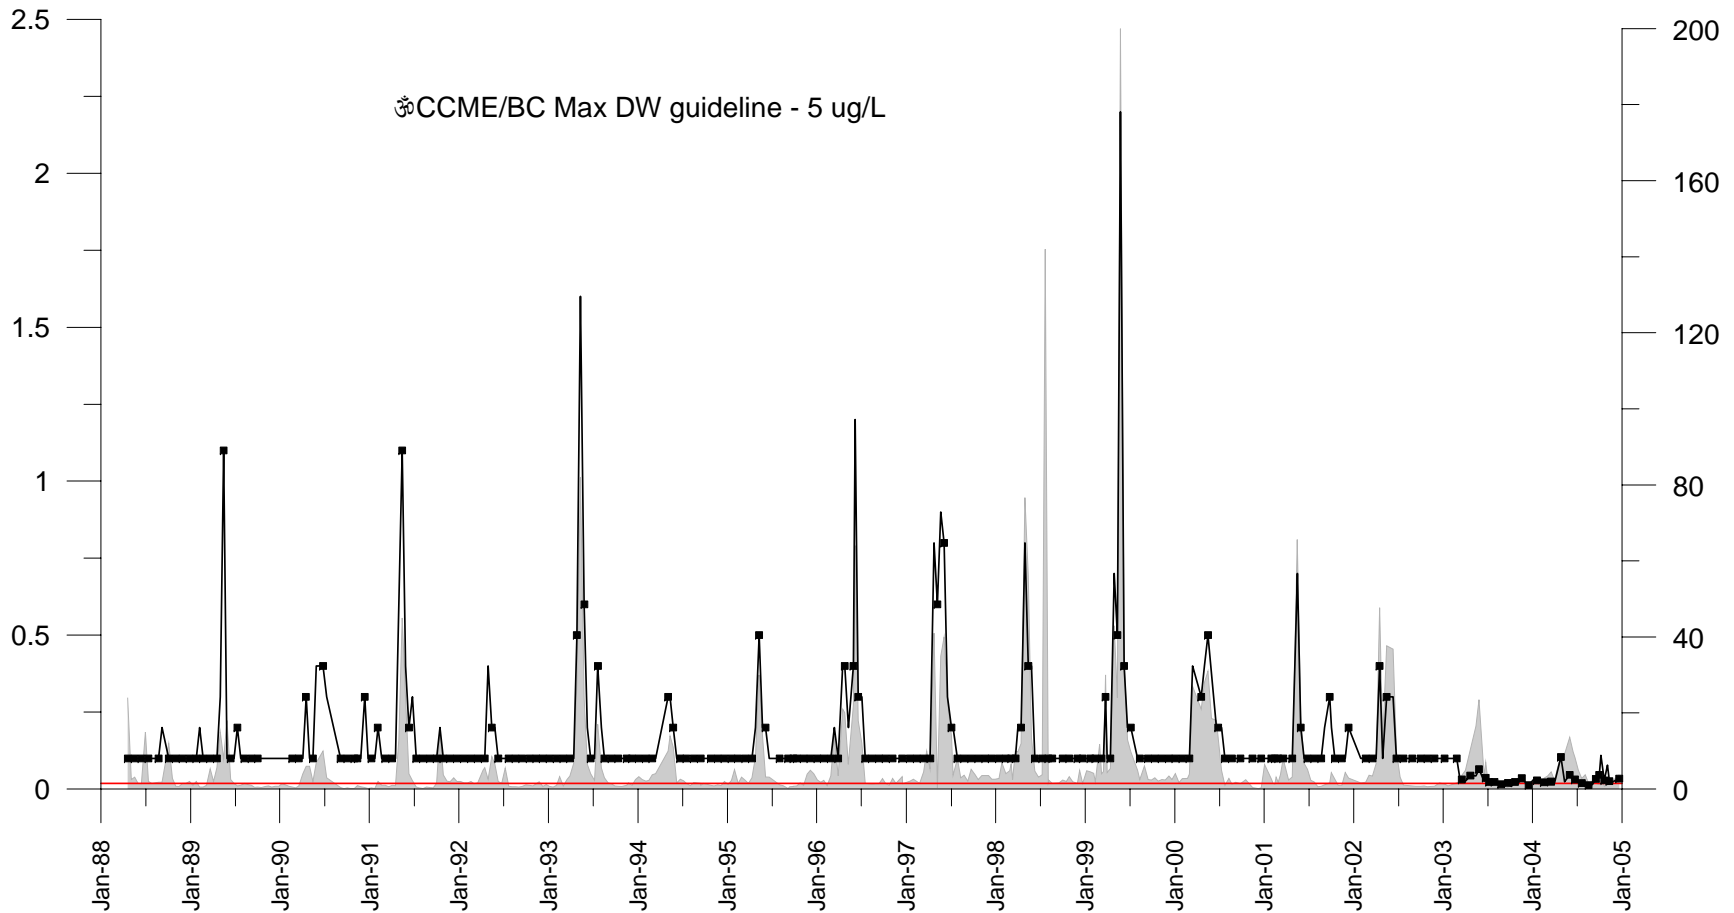
Figure 18

Cadmium (Figures 18 and 19): values seemed to fluctuate with turbidity, which means that higher values would be associated with particulate matter and would likely not be biologically available. Although values seem to be getting lower through the period of record, this is likely more a phenomenon related to decreasing detection limits and improved analytical capabilities through time, rather than a real decrease in concentration. Lower cadmium values, and their detection limits, during the 2003-2004 period also coincided with lower turbidity concentrations. Additional data need to be collected to determine whether turbidity and cadmium are in fact beginning to decline.

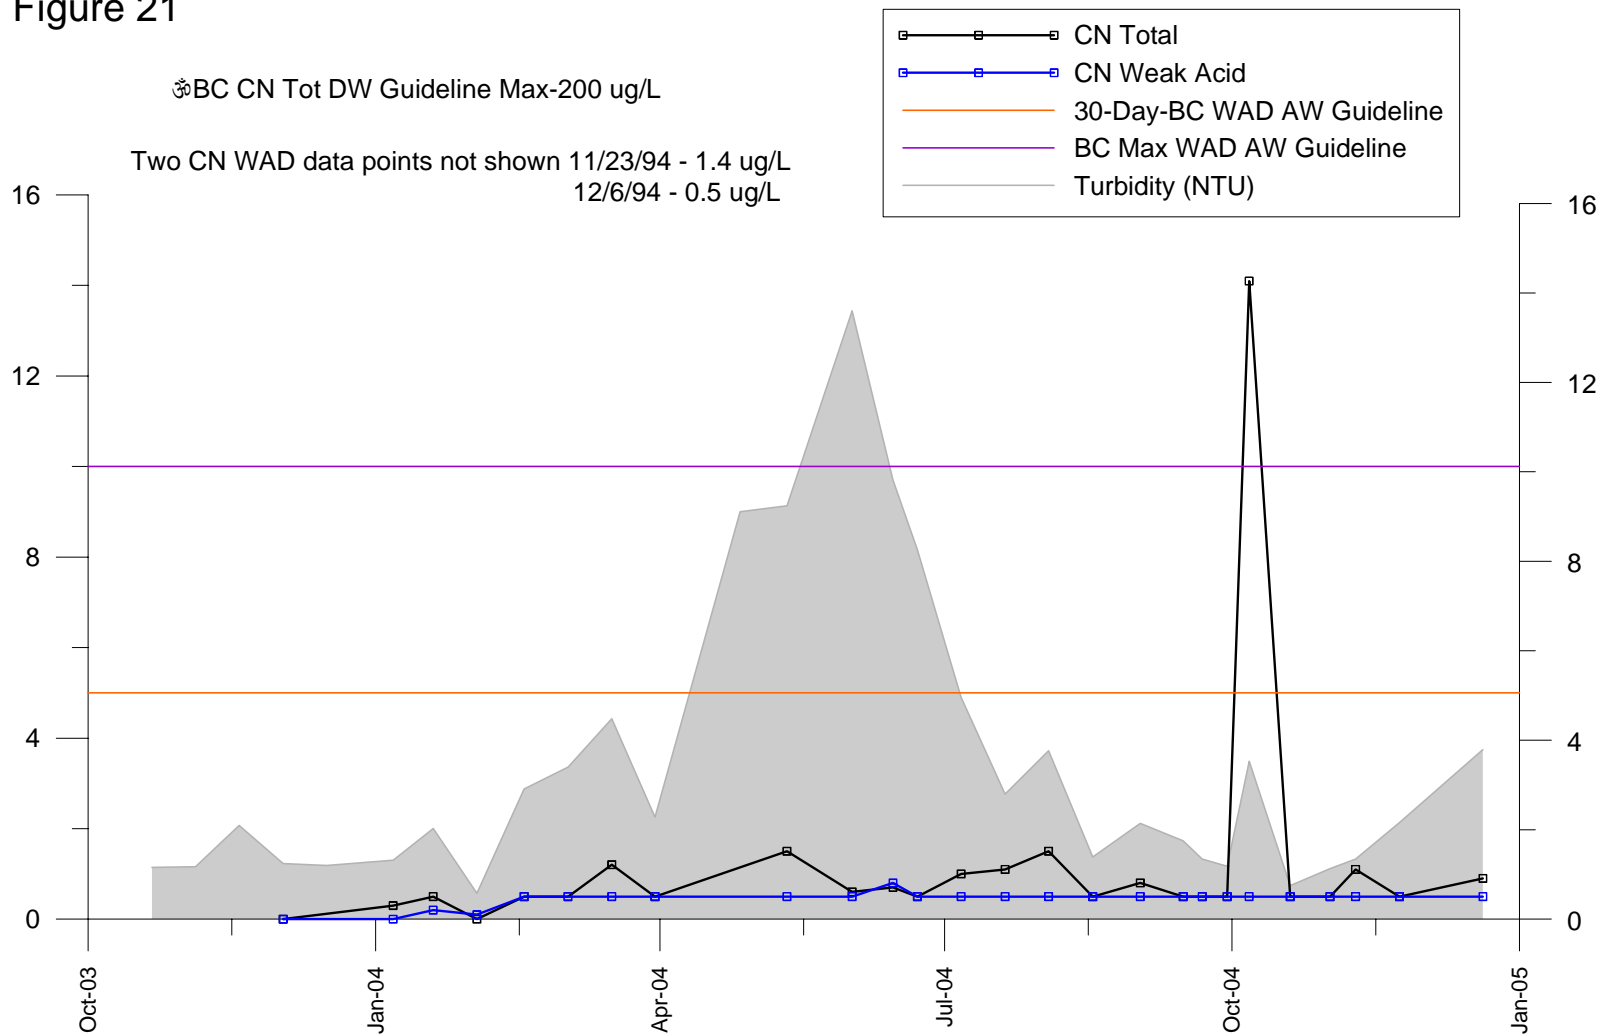
Figure 21

Cyanide (Figure 21): values generally were well below the maximum and 30-day average guidelines for weak-acid dissociable cyanide. One exception was a total cyanide value in October 2004. Since data for only one year have been collected, additional sampling is required before any trends might become evident.

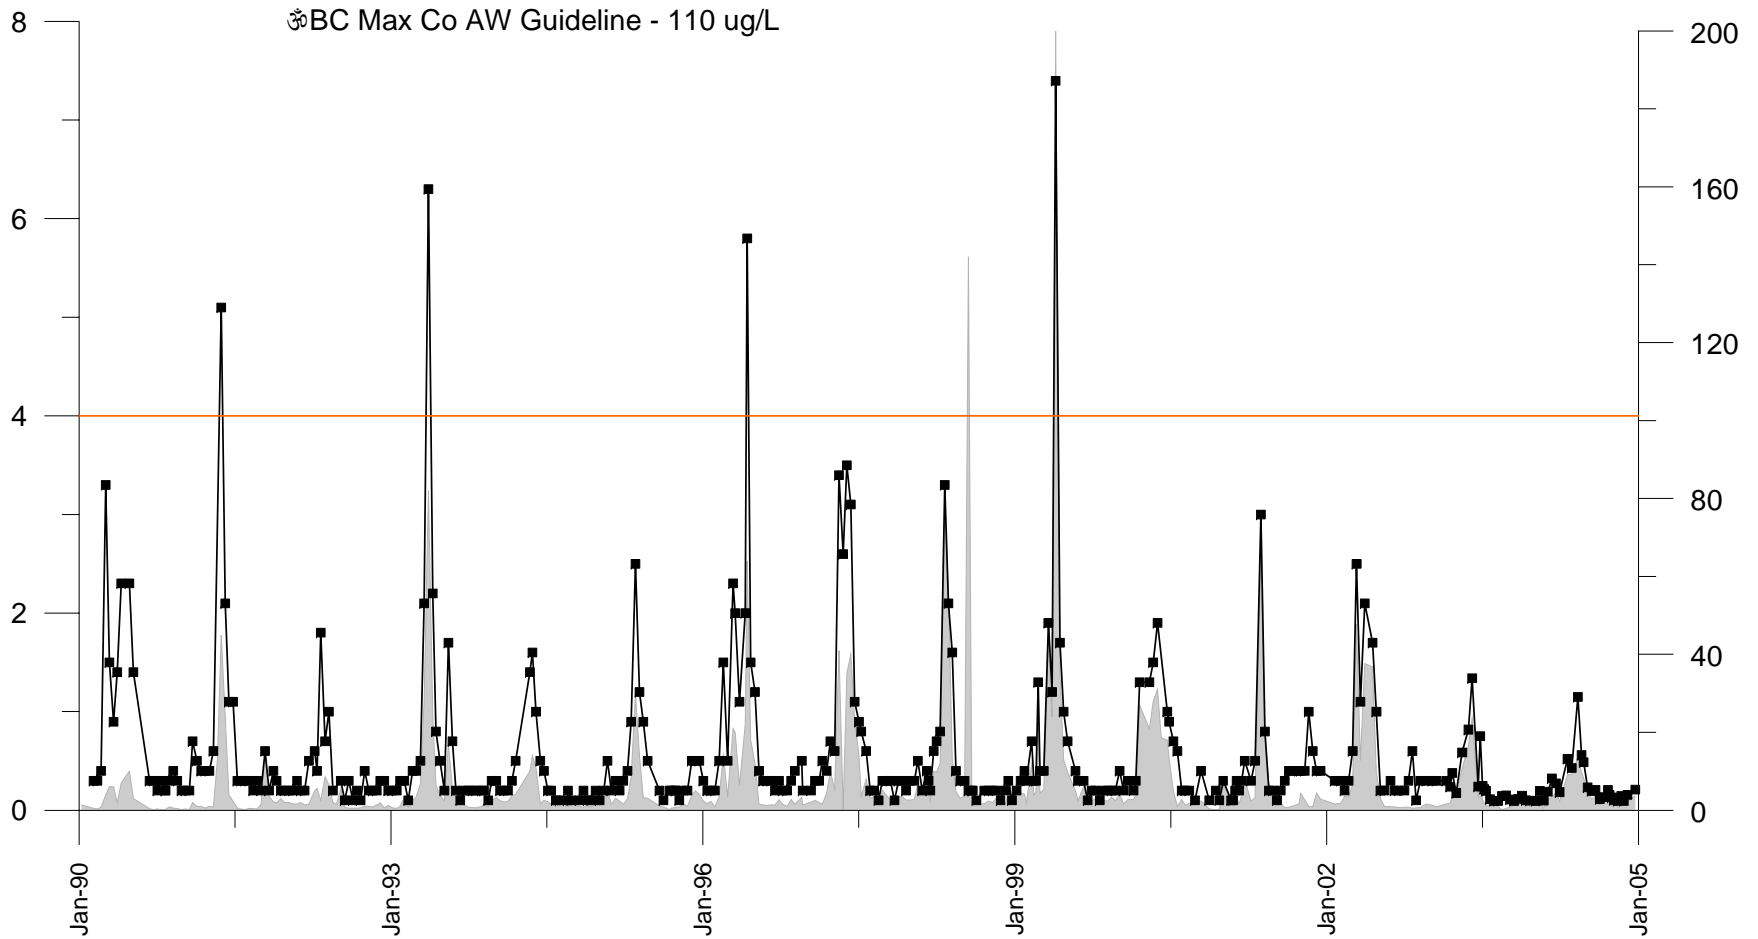
Cobalt Total (ug/L)
Figure 22

Cobalt (Figure 22): values seemed to be correlated with turbidity, which means that higher cobalt values are associated with particulate matter and not likely biologically available. The occasional individual value has exceeded the BC guideline of 4 µg/L for the 30-day mean concentration; however, all individual values were well below the guideline for maximum concentrations of 110 µg/L. Lower cobalt values in 2003-2004 coincided with lower turbidity concentrations. Additional data need to be collected to determine whether turbidity and cobalt are in fact beginning to decline.

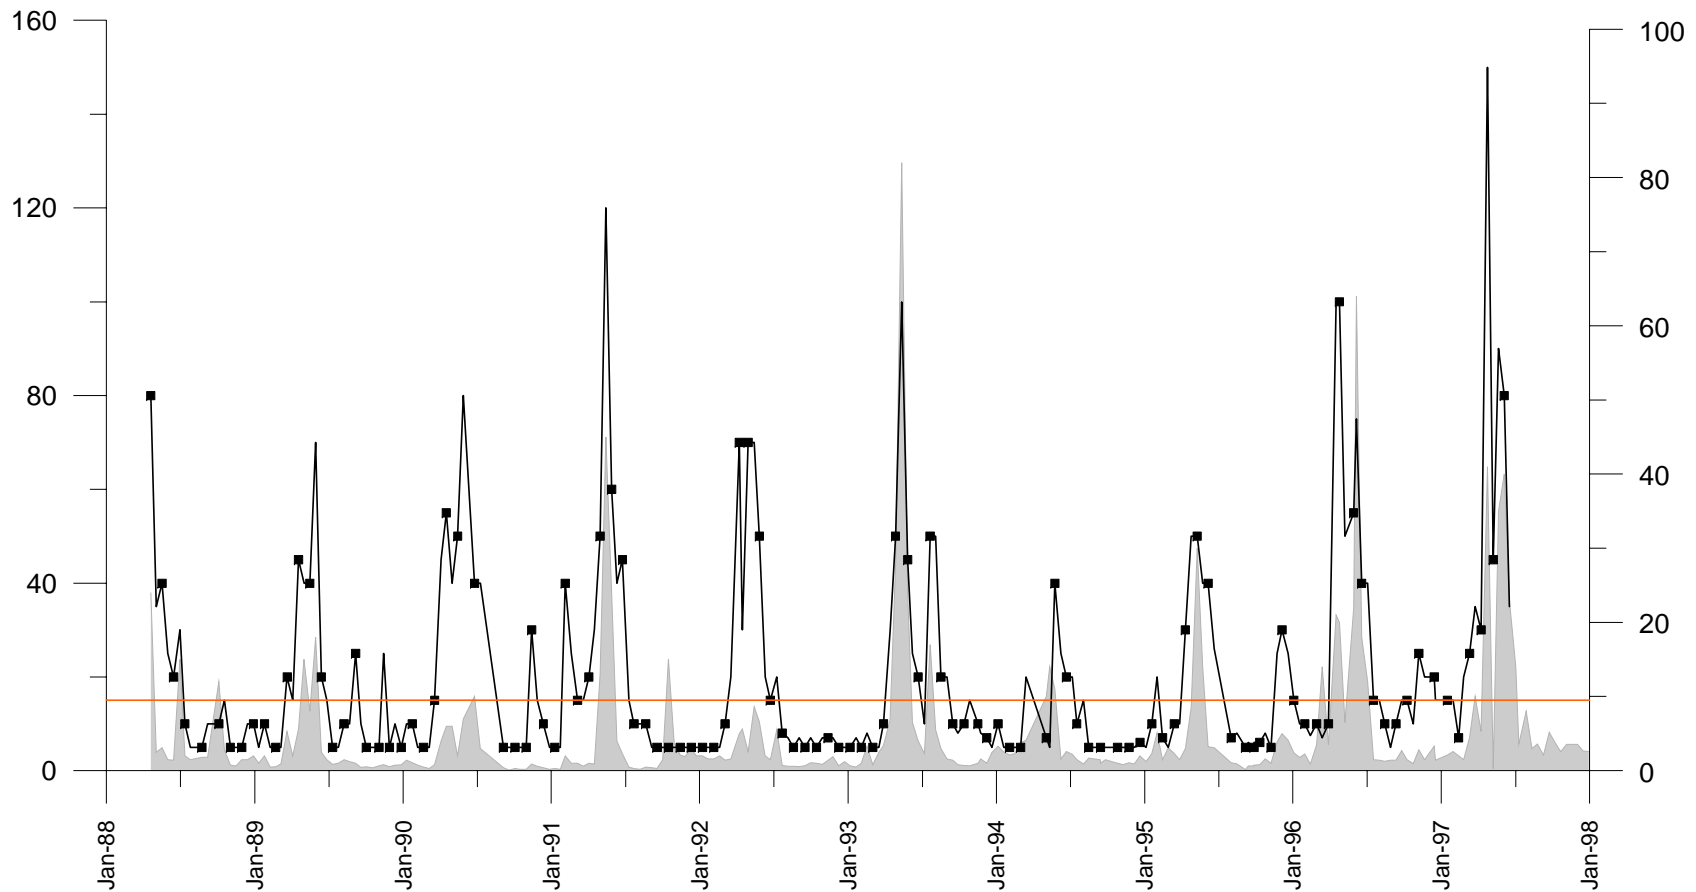
Figure 23

Colour: apparent colour (Figure 23) values from 1988 until 1998 seemed to fluctuate with turbidity and regularly exceeded the drinking water guideline of 15 TCU for true colour; however, this is to be expected since true colour is measured on a filtered sample (i.e., turbidity removed). True colour values (Figure 24) began to be measured in 1997 and were lower than apparent colour values, as expected; however, values seem to fluctuate with turbidity and regularly exceeded the drinking water guideline.

- Colour values and fecal coliforms and E. Coli often exceeded guidelines for drinking water at the source; however, these were related to turbidity events and complete treatment of the source water would be needed prior to use for drinking.

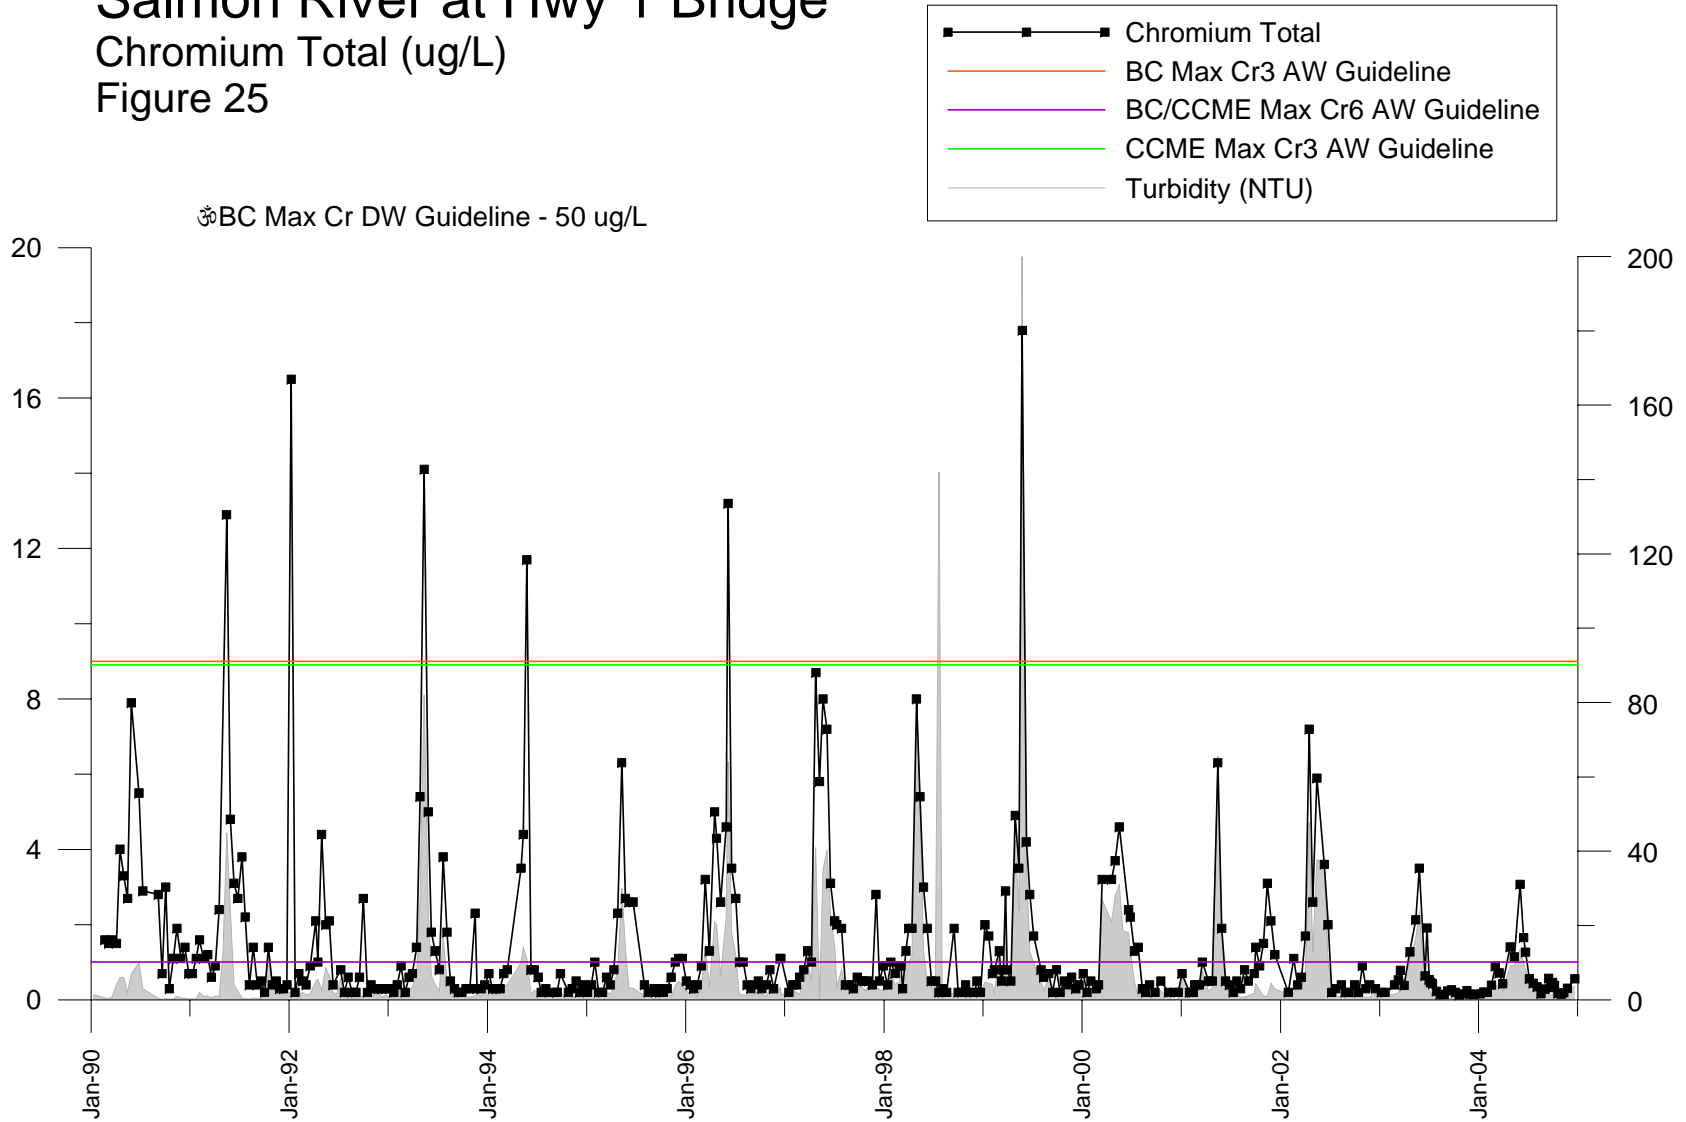
Figure 25

Chromium (Figure 25): values in the 1990's exceeded the guideline for trivalent chromium and hexavalent chromium; however, since the year 2000, only the guideline for hexavalent chromium has been exceeded. Values seem to fluctuate with turbidity

values, meaning that the higher chromium values are likely in particulate form and not biologically available. There is a very weak trend identified using a linear regression ($R^2 = 0.017$) of decreasing concentrations through time; however, this is likely related to lower turbidity concentrations in the post-2000 period. We recommend that either trivalent and hexavalent forms of chromium be measured in the future or guidelines be developed for total chromium values.

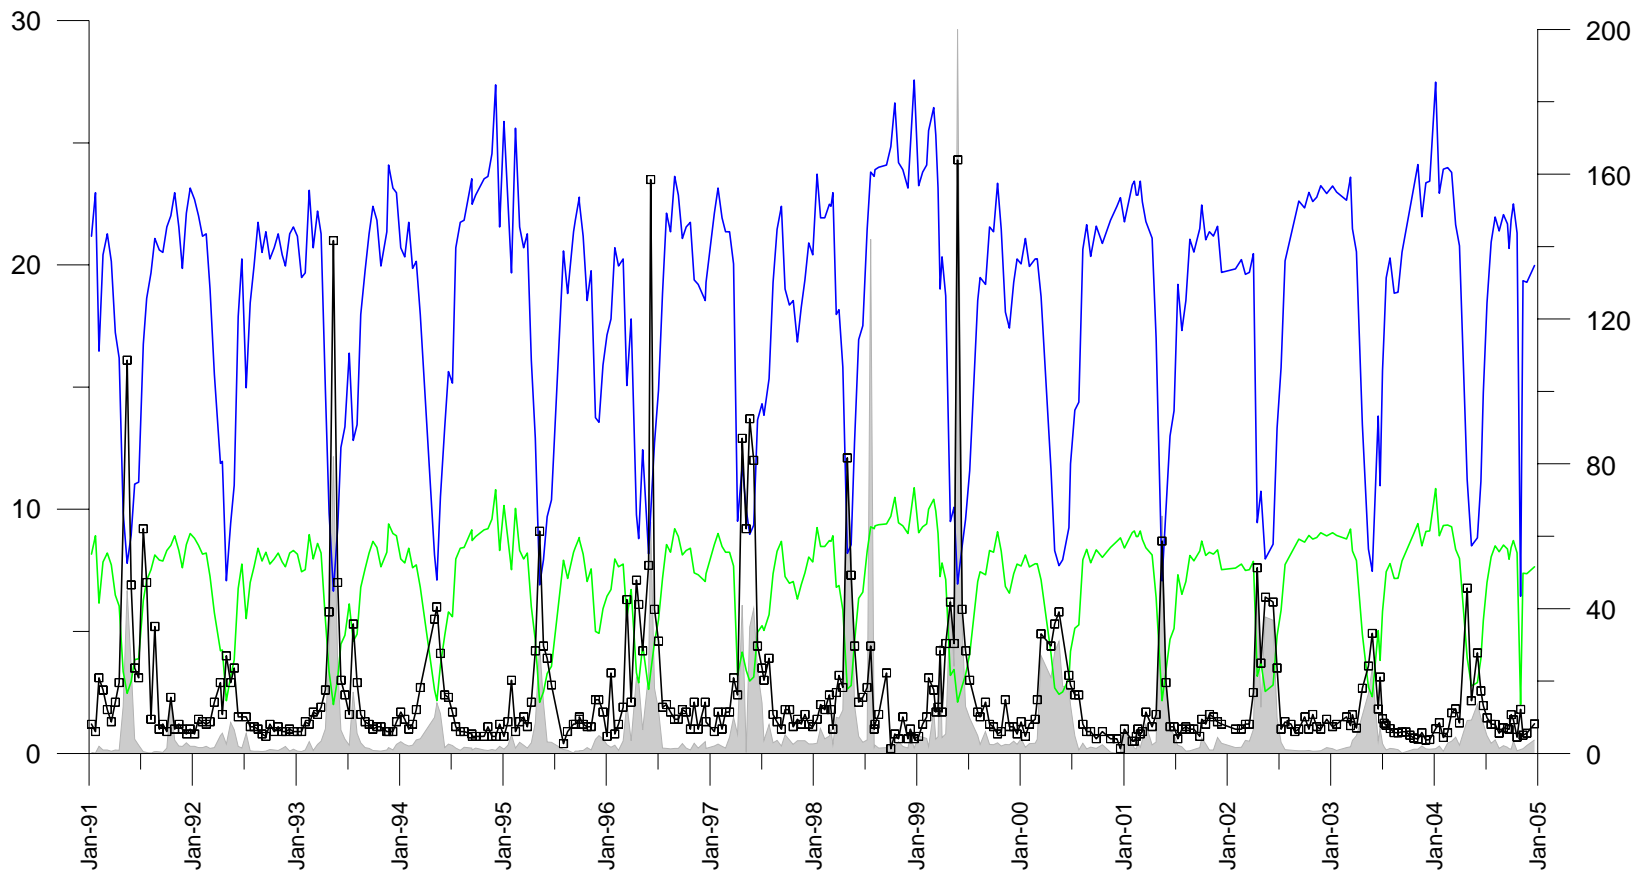
Figure 27

Copper (Figures 26 and 27): values generally met the guidelines (hardness-dependent) for maximum and 30-day mean concentrations; however, when these were exceeded, turbidity values were also high. This means that the higher copper values are in particulate form and not likely biologically available. Higher values in the late 1980's were quite high due to widespread contamination because of the failure of preservative vial cap liners between 1986 and 1991.

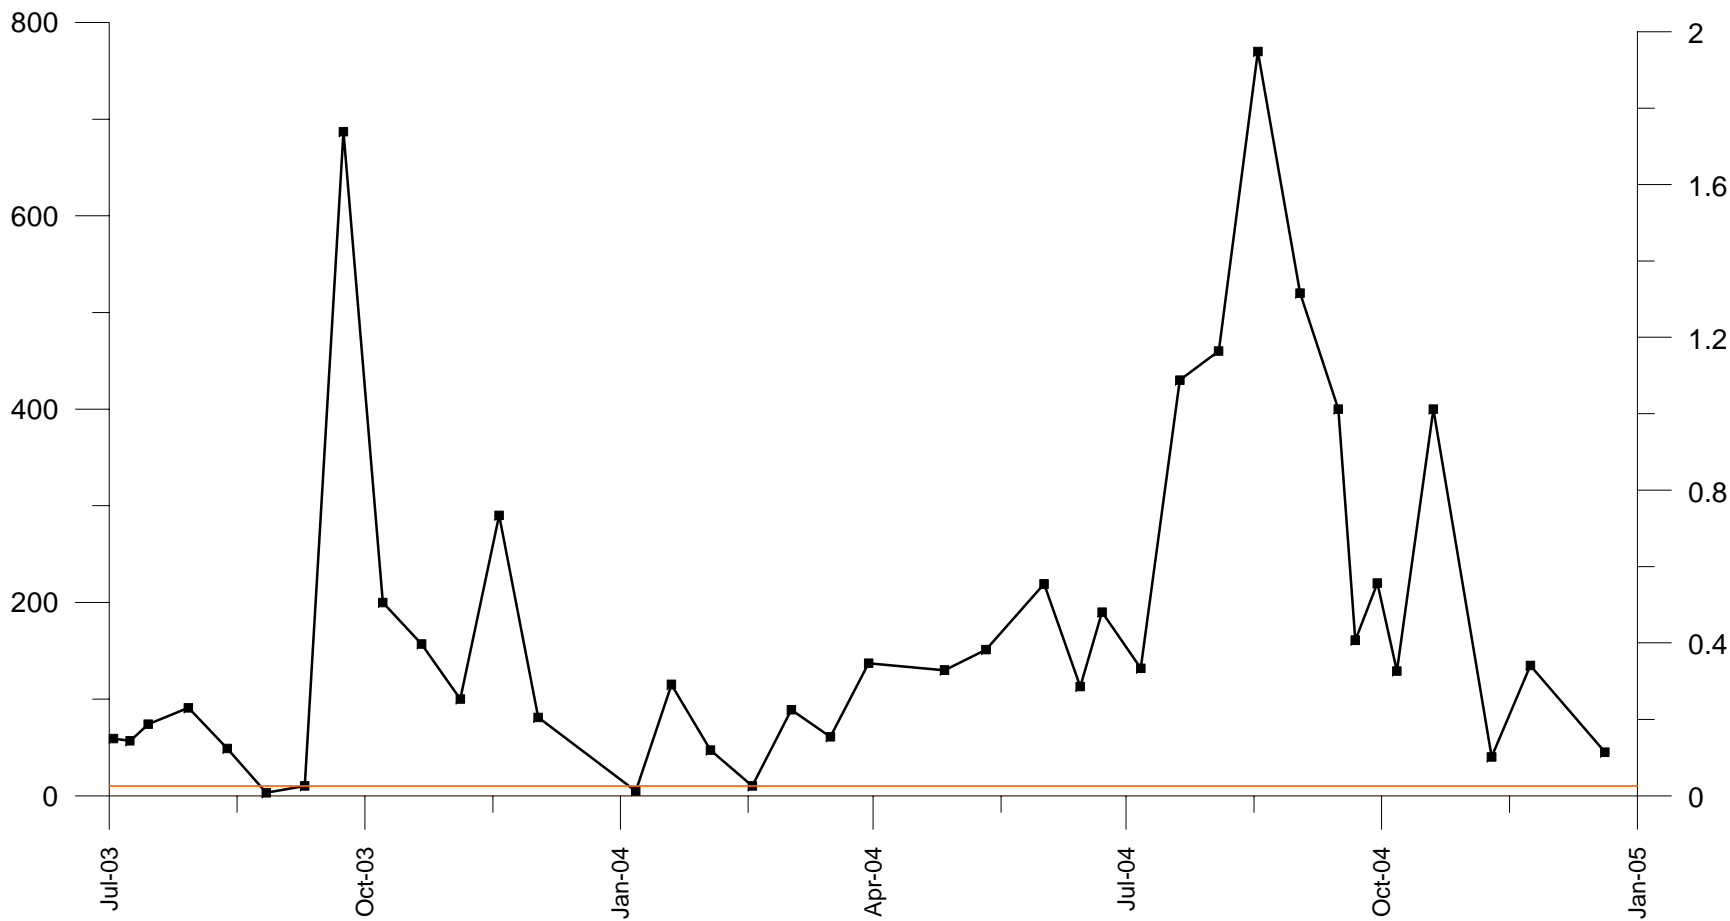
E Coli (CFU/100mL)
Figure 28

E. Coli (Figure 28) and **Fecal Coliforms** (Figure 31): regularly exceeded the water quality guideline and short and long-term water quality objectives, respectively, for drinking water sources. High fecal coliforms seem to be correlated with high turbidity concentrations. Drinking water taken from the Salmon River would require complete treatment.

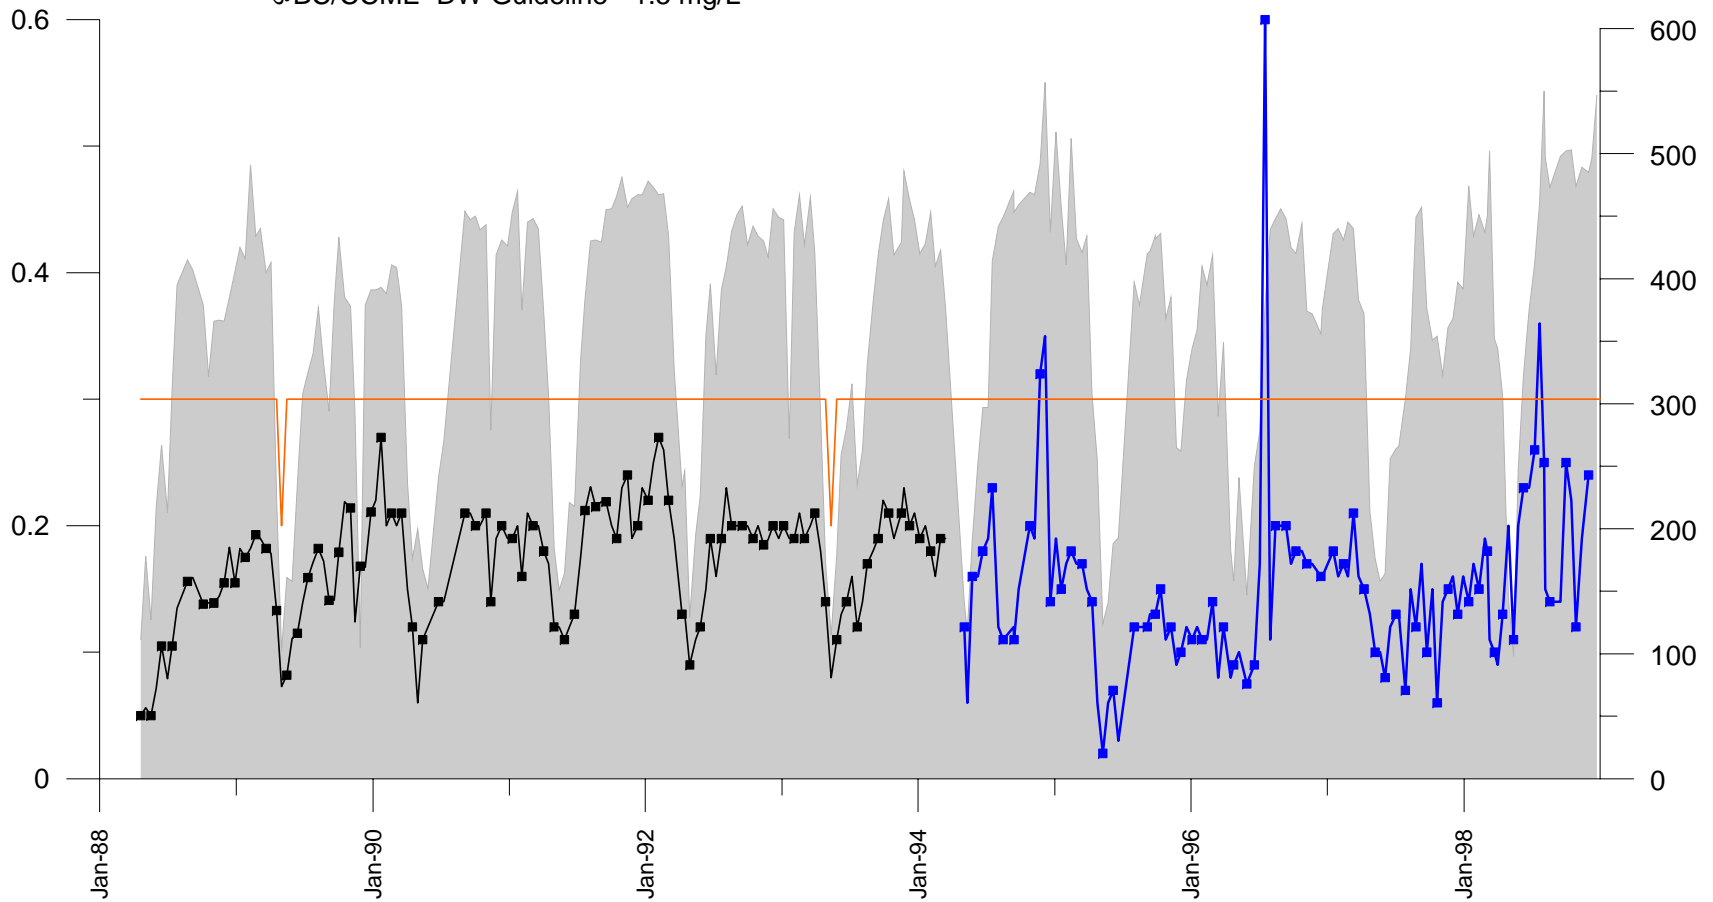
Figure 29

Fluoride (Figure 29): values were measured only between 1988 and 1999. Values generally met the aquatic life guideline of 0.3 µg/L. High fluoride values coincided with periods of high specific conductivity and low river flows, suggesting that the fluoride was a result of groundwater contributions to the base flow of the river.

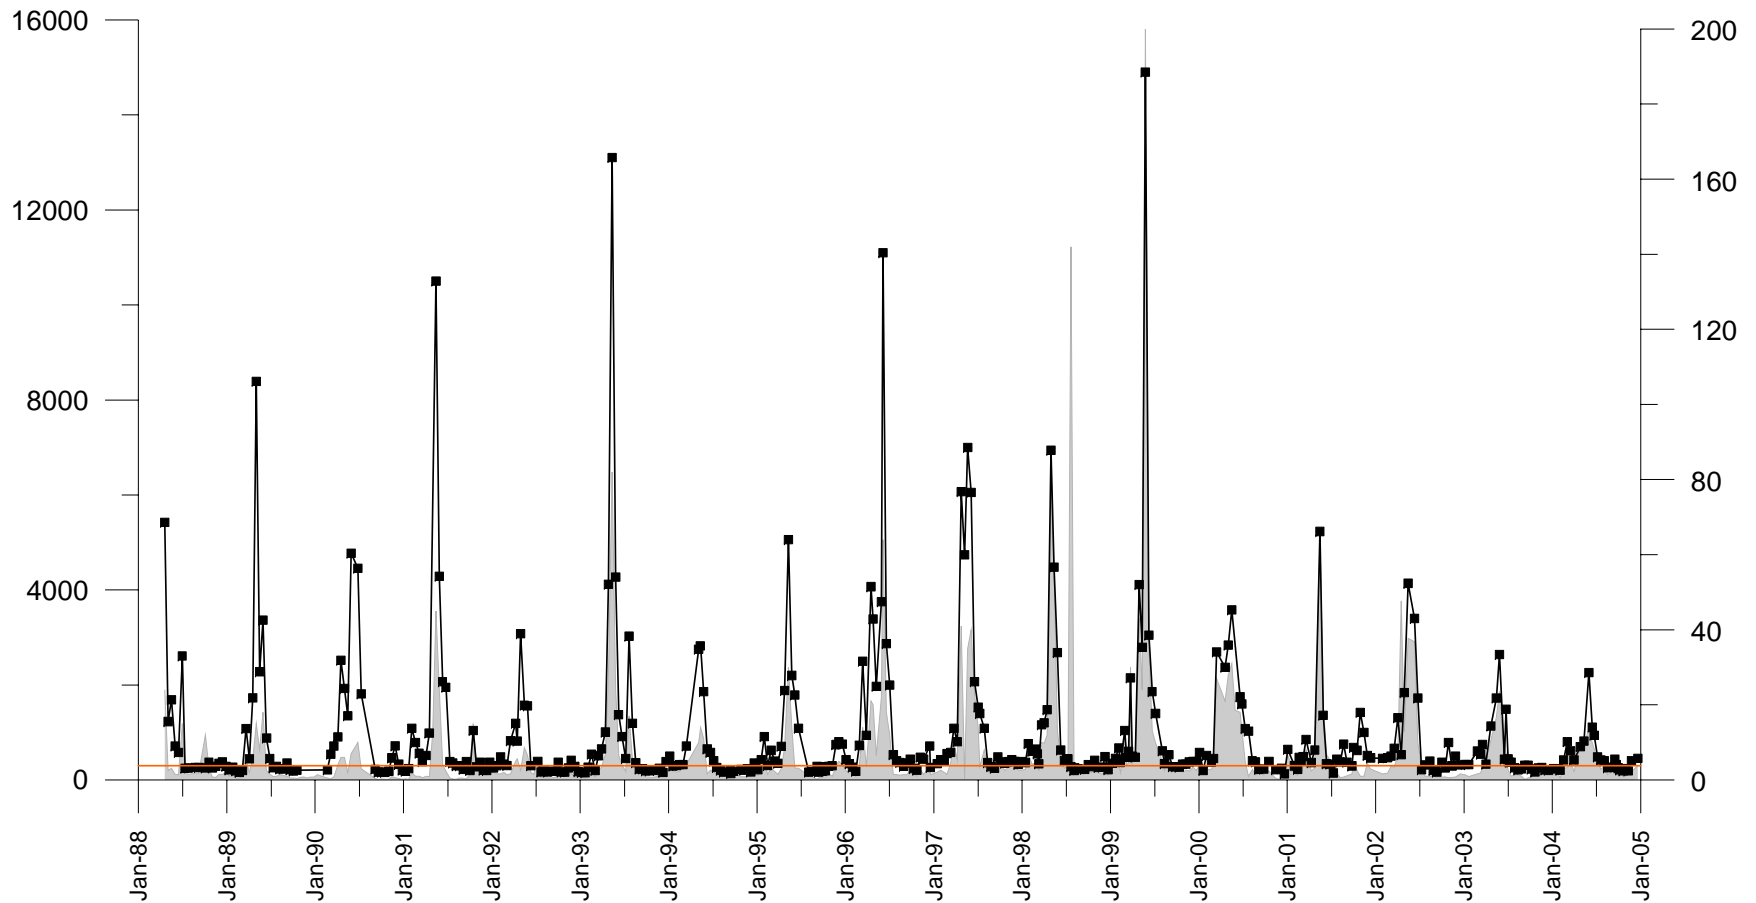
Iron Total (ug/L)
Figure 30

Iron (Figure 30): values regularly exceeded the guideline for the protection of aquatic life and drinking water supplies (aesthetics) of 300 µg/L. High iron values were correlated with high turbidity concentrations, meaning that the iron was in particulate form and not biologically available. It would also be removed in water treatment processes for drinking water supplies. Peak iron values since 2000 seem to be lower than during the previous decade; however, these lower values are likely the result of lower turbidity values during that period.

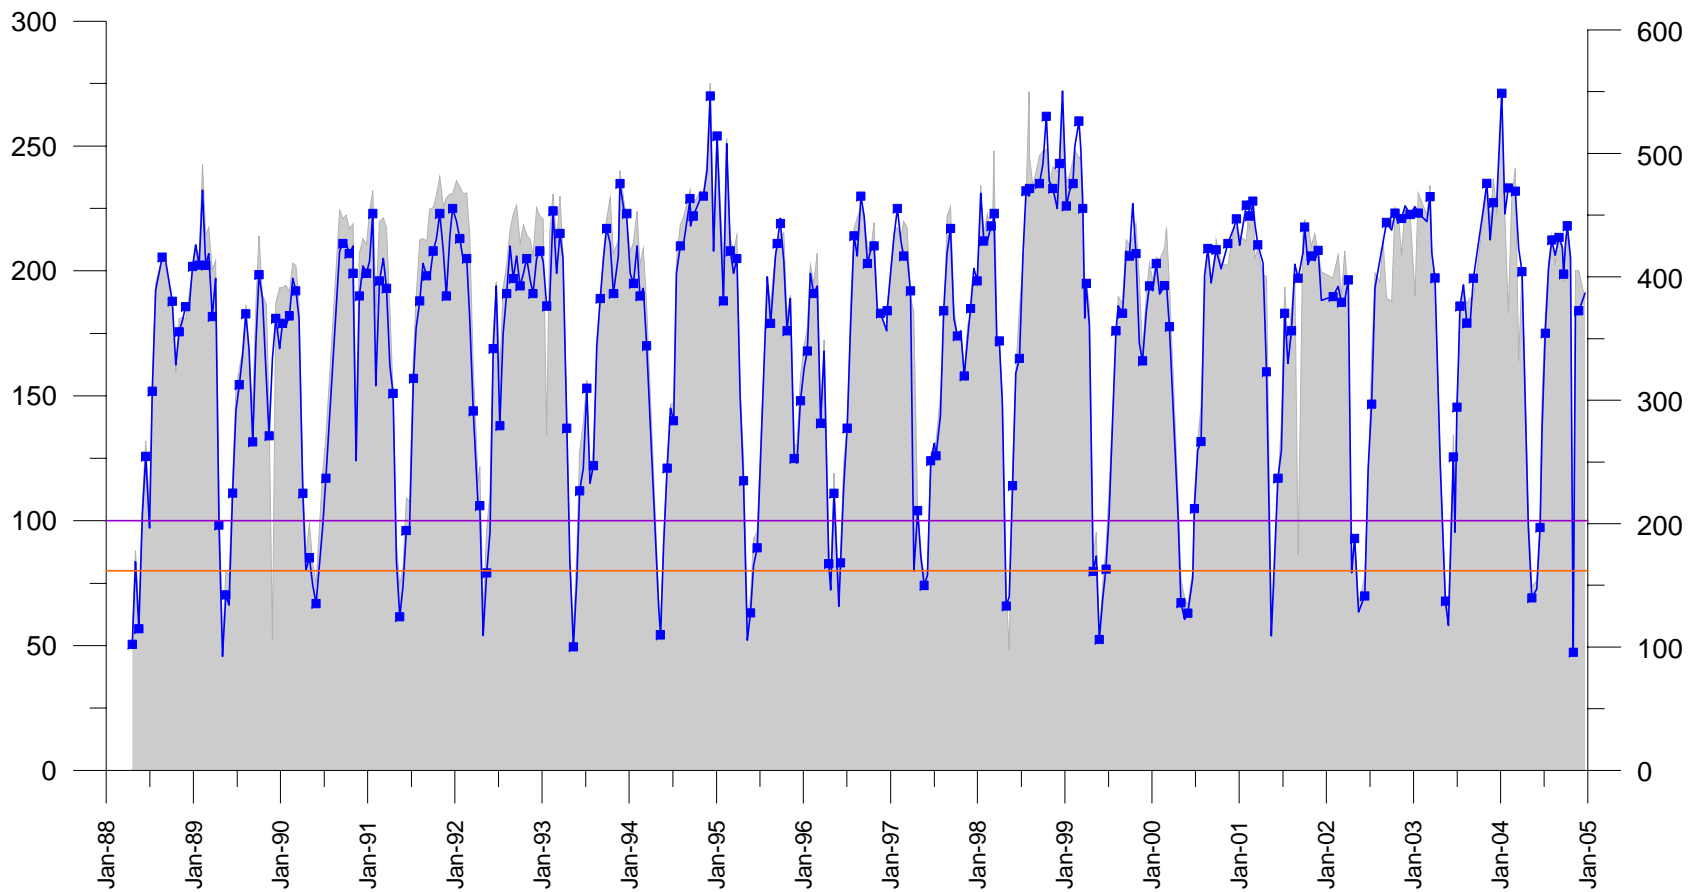
Figure 33

Hardness (Figure 33): values were strongly correlated with specific conductivity and low river flows, suggesting that the hardness was a result of groundwater contributions to the base flow of the river. Values throughout the year were generally higher than the 100 mg/L level for drinking water supplies.
