WATER QUALITY MONITORING AGREEMENT

WATER QUALITY ASSESSMENT OF Salmon River AT SALMON ARM (1985 – 2004)

Prepared by:
L. G. Swain, P. Eng.
B.C. Ministry of Environment

March 2007

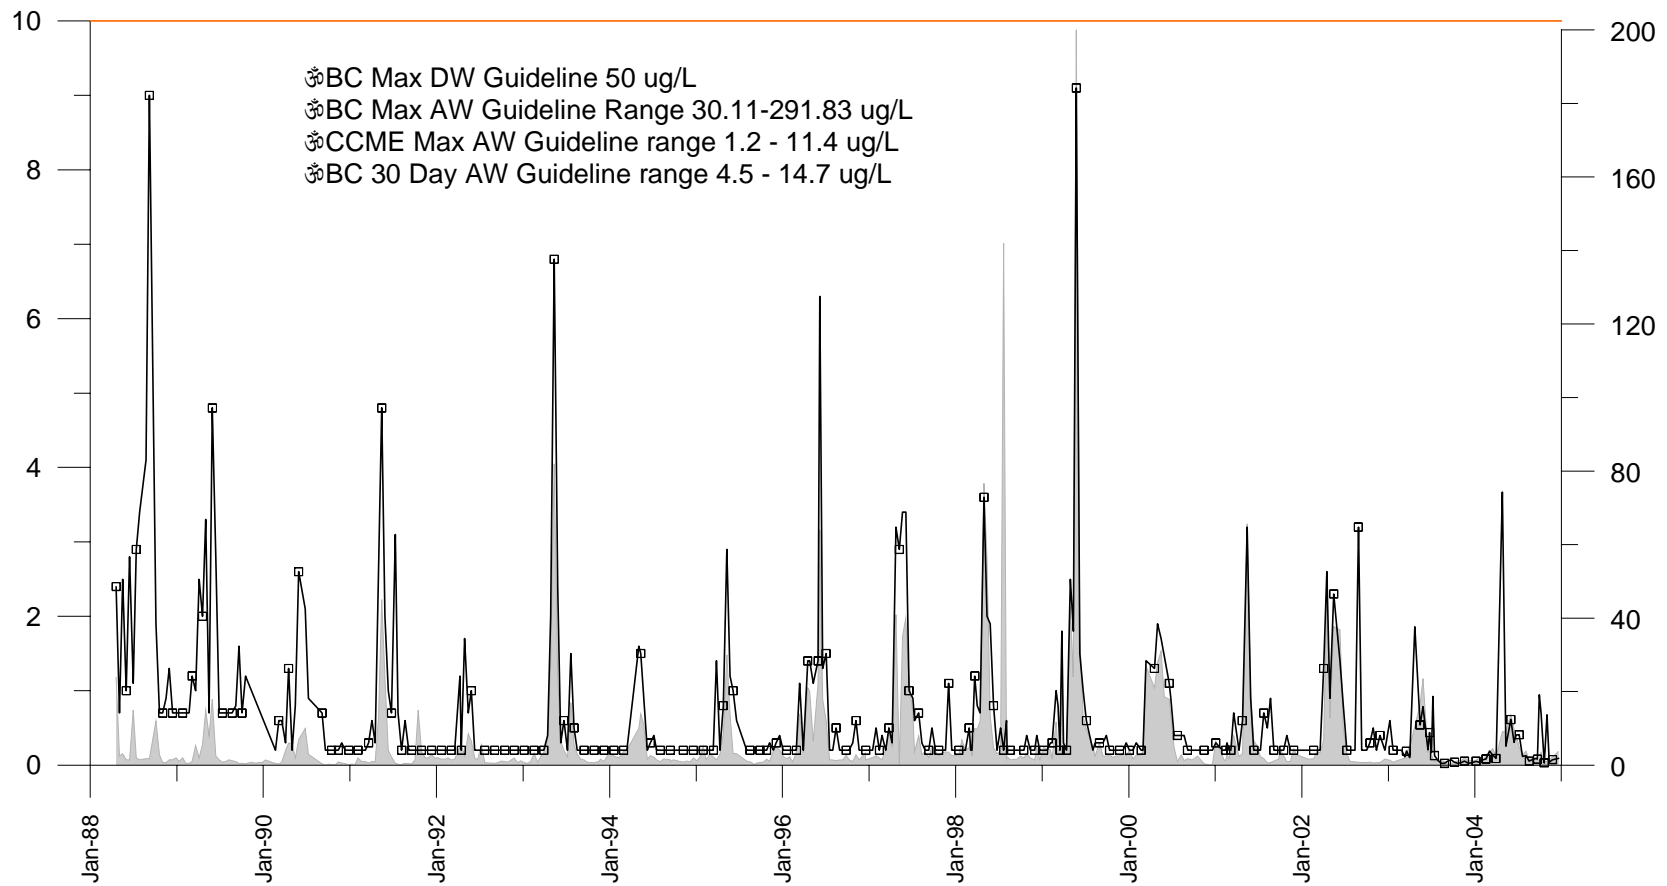
Figure 36

Lead (Figure 36): values seem to correlate with turbidity, meaning that high lead values are in particulate form and not likely biologically available. Values were generally below all guidelines for aquatic life and drinking water supplies, with only two individual values exceeding the lowest BC 30-day mean guideline of 4.5 µg/L. Analytical detection limits for lead were reduced in 2003 from the 0.2 µg/L level, which means that in future years, trends to lower values might be suspected; however, the lower detection limits may be responsible for such observations.

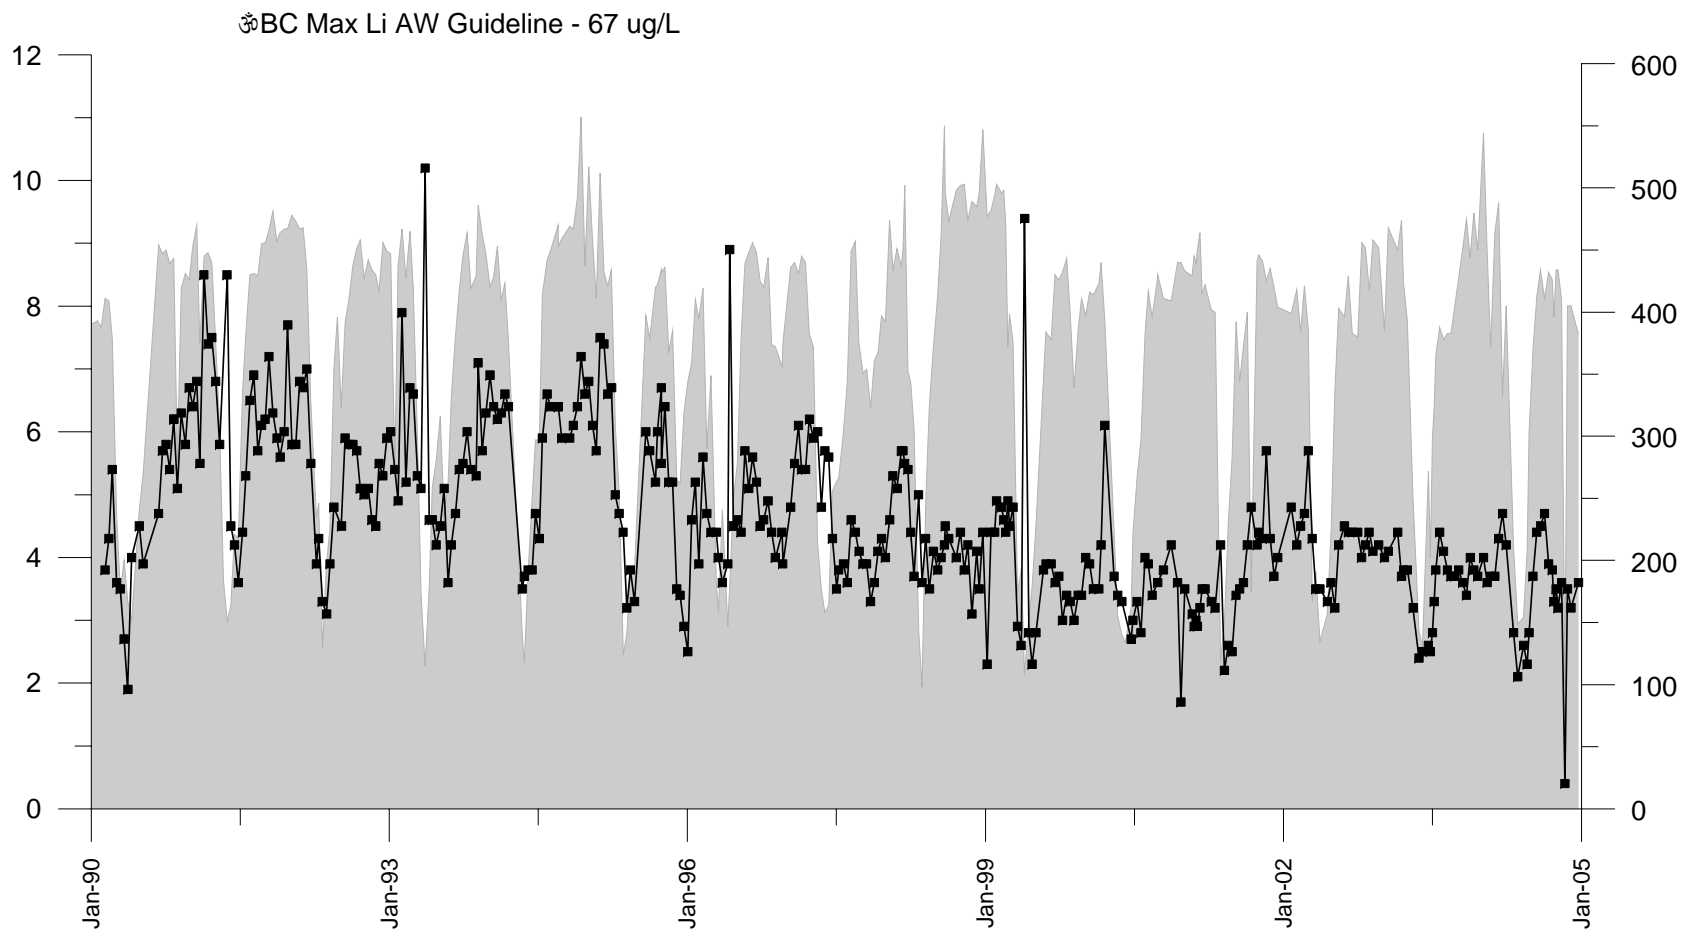
Figure 37

Lithium (Figure 37): values have shown a strong decline during the period of record ($R^2 = 0.31$) but have always been below the BC guideline to protect aquatic life of 67 µg/L. Values also seem to be correlated with high specific conductivity and low flows, meaning that the lower values are likely associated with a groundwater contribution to base river flow.

- Lithium and extractable silicon were showing distinct decreases in concentrations over time.

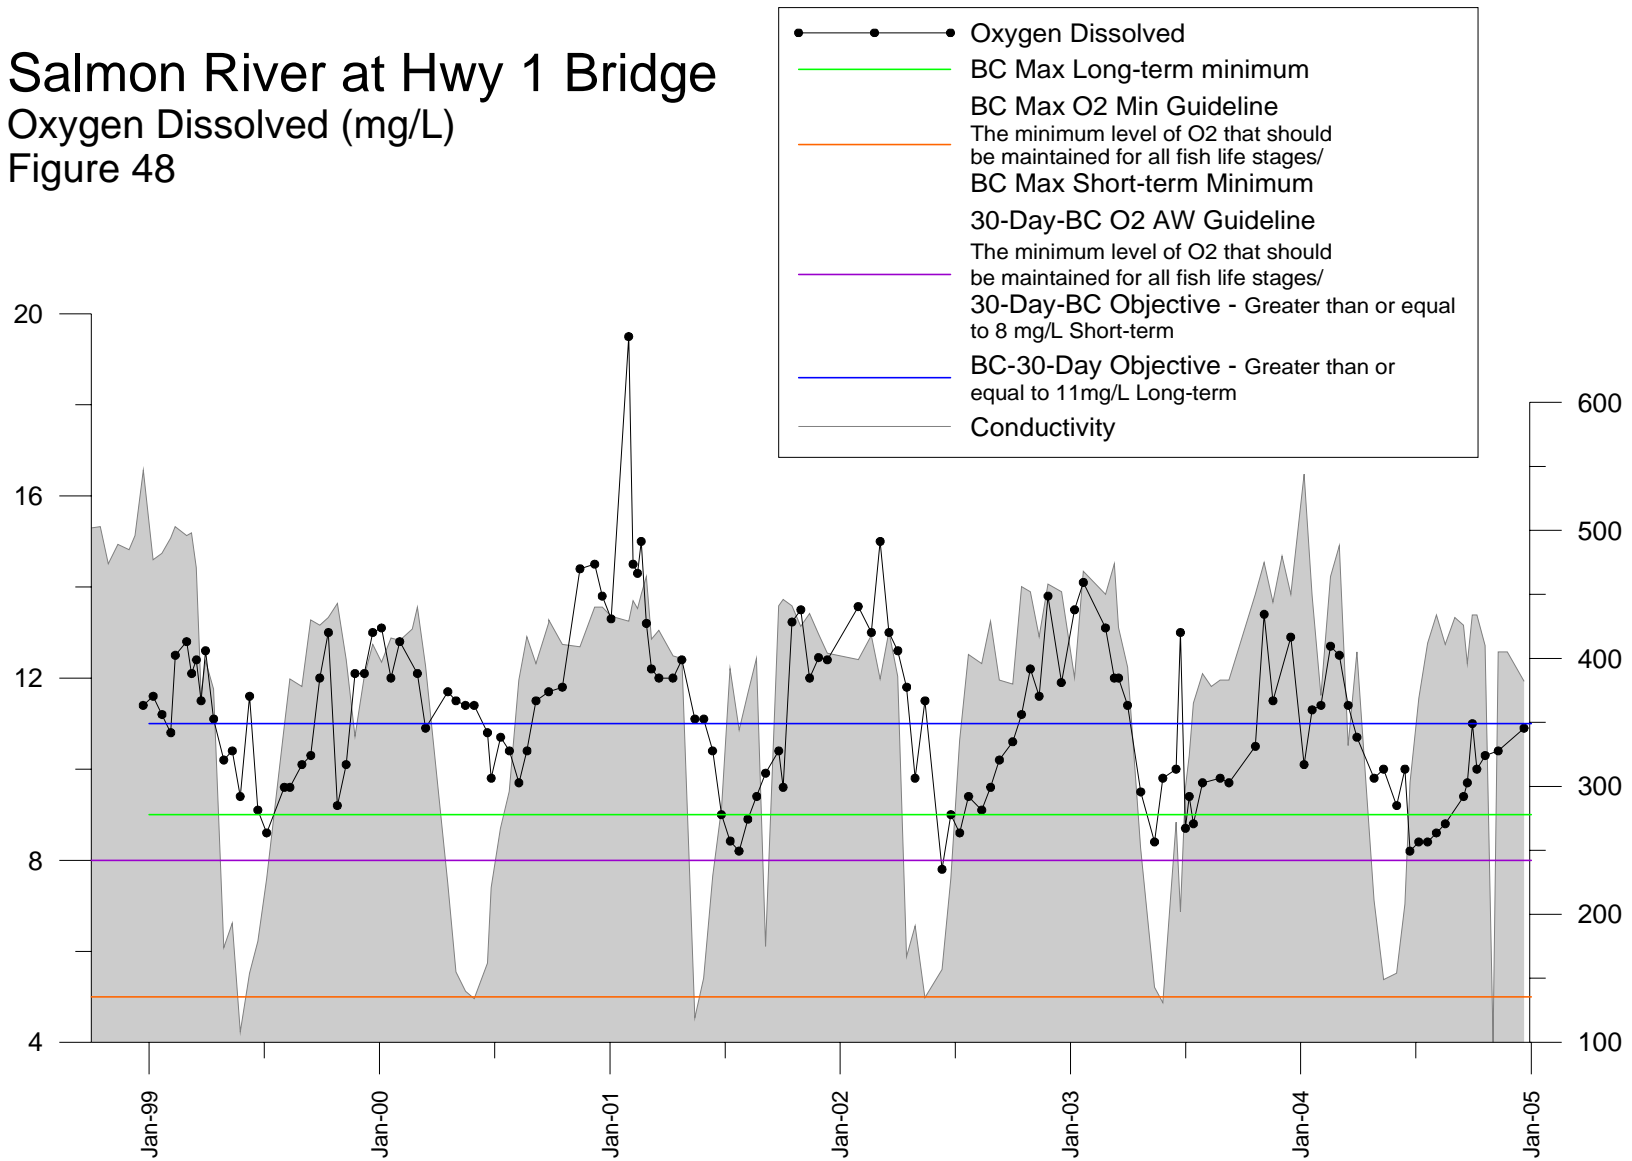
Salmon River at Hwy 1 Bridge
Oxygen Dissolved (mg/L)
Figure 48

Dissolved Oxygen (Figure 48): values seem to fluctuate with conductivity, which is not surprising in that conductivity peaks occur when there are low flows in the colder months of the year, and under normal situations, dissolved oxygen concentrations rise at colder temperatures. Only one value was slightly below the 8 mg/L water quality objective.

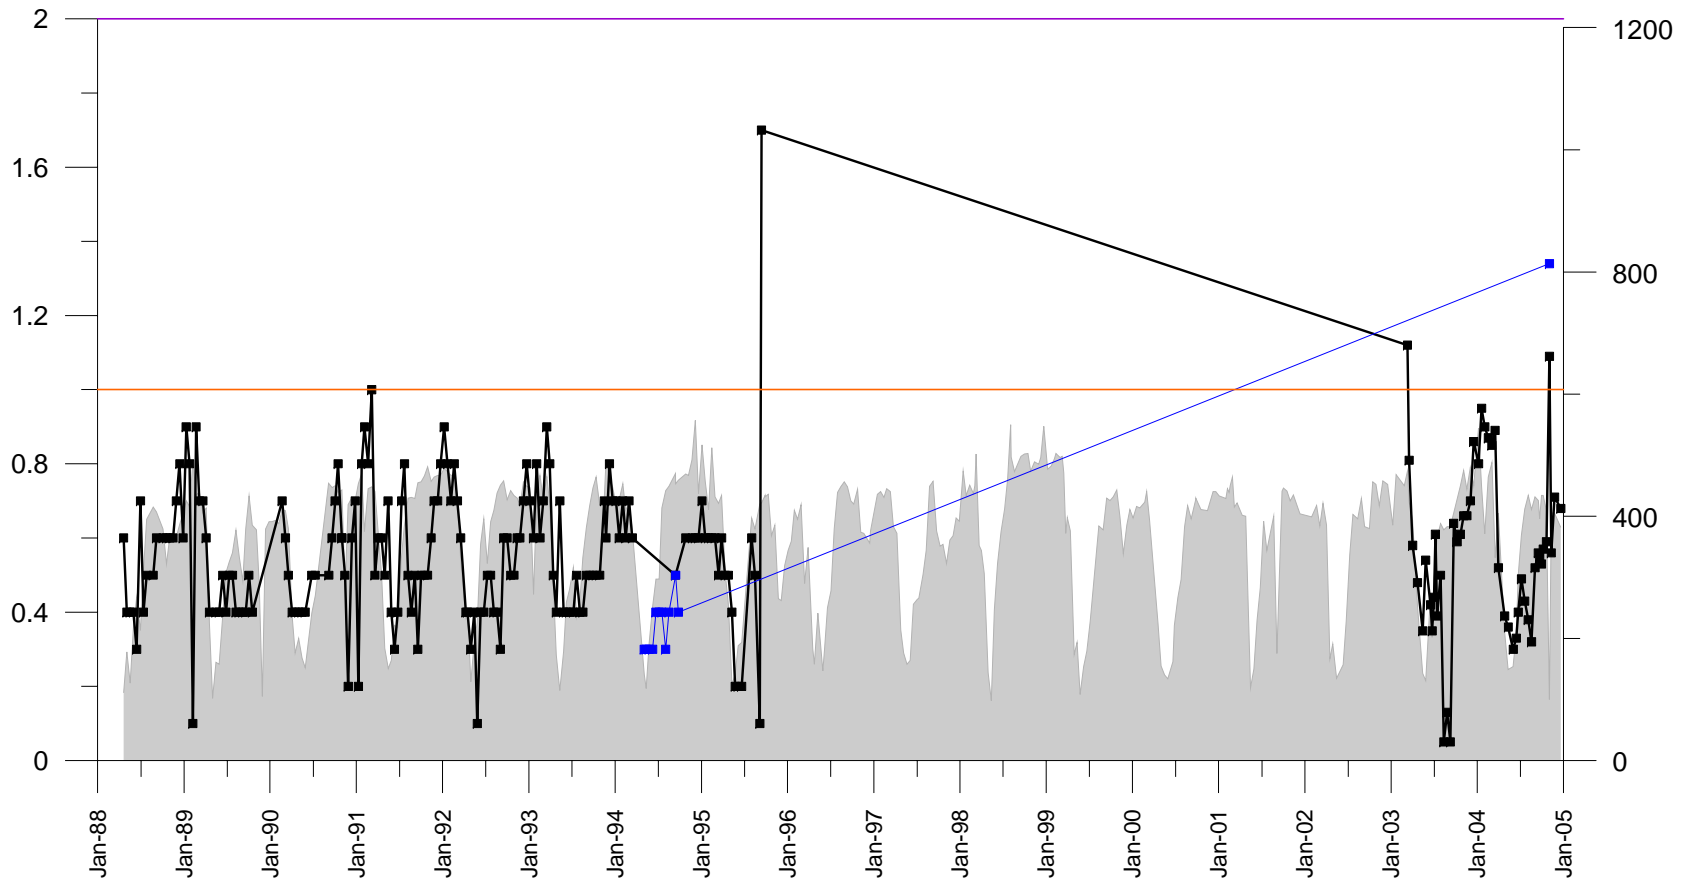
Figure 56

Selenium (Figure 56): values on occasion exceeded the guideline to protect aquatic life of 1 µg/L. Selenium values seemed to be correlated with specific conductivity with highest values occurring during low flow conditions.

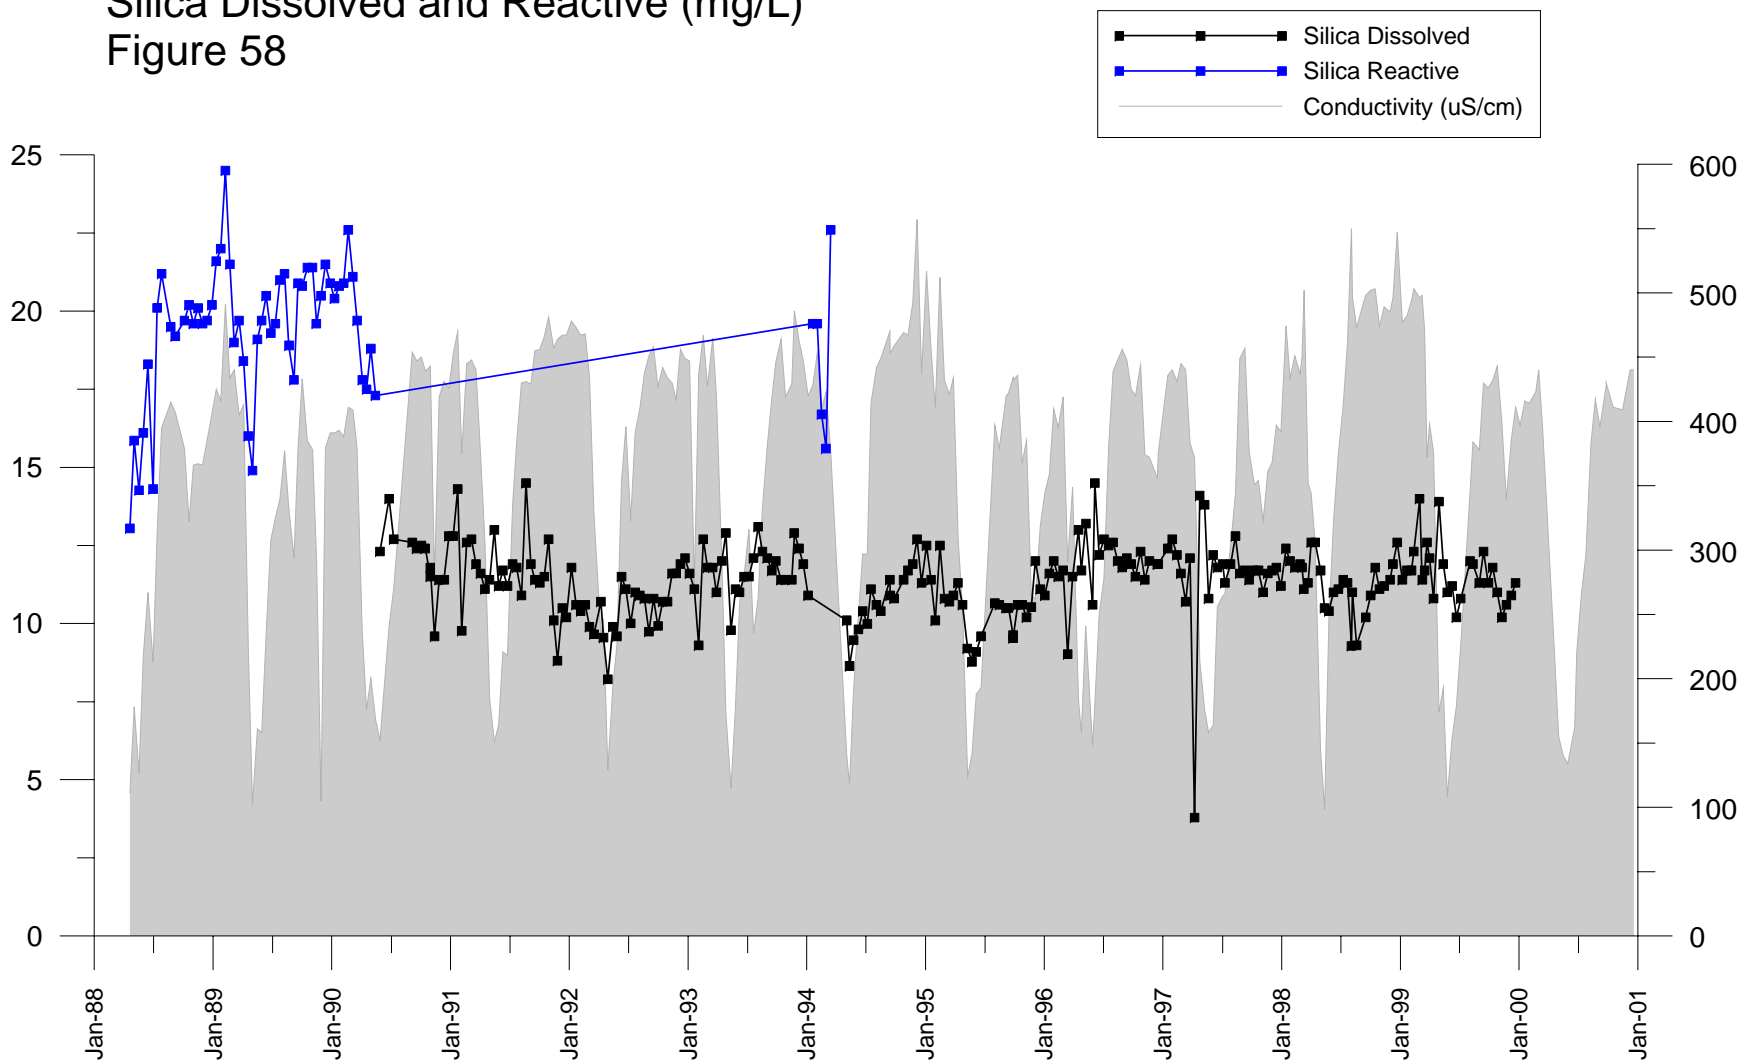
Figure 58

Silica and Silicon (Figure 58): Values for extractable silicon have decreased considerably over the period from 1999 until 2002, with a linear regression having a R^2 value of 0.23.

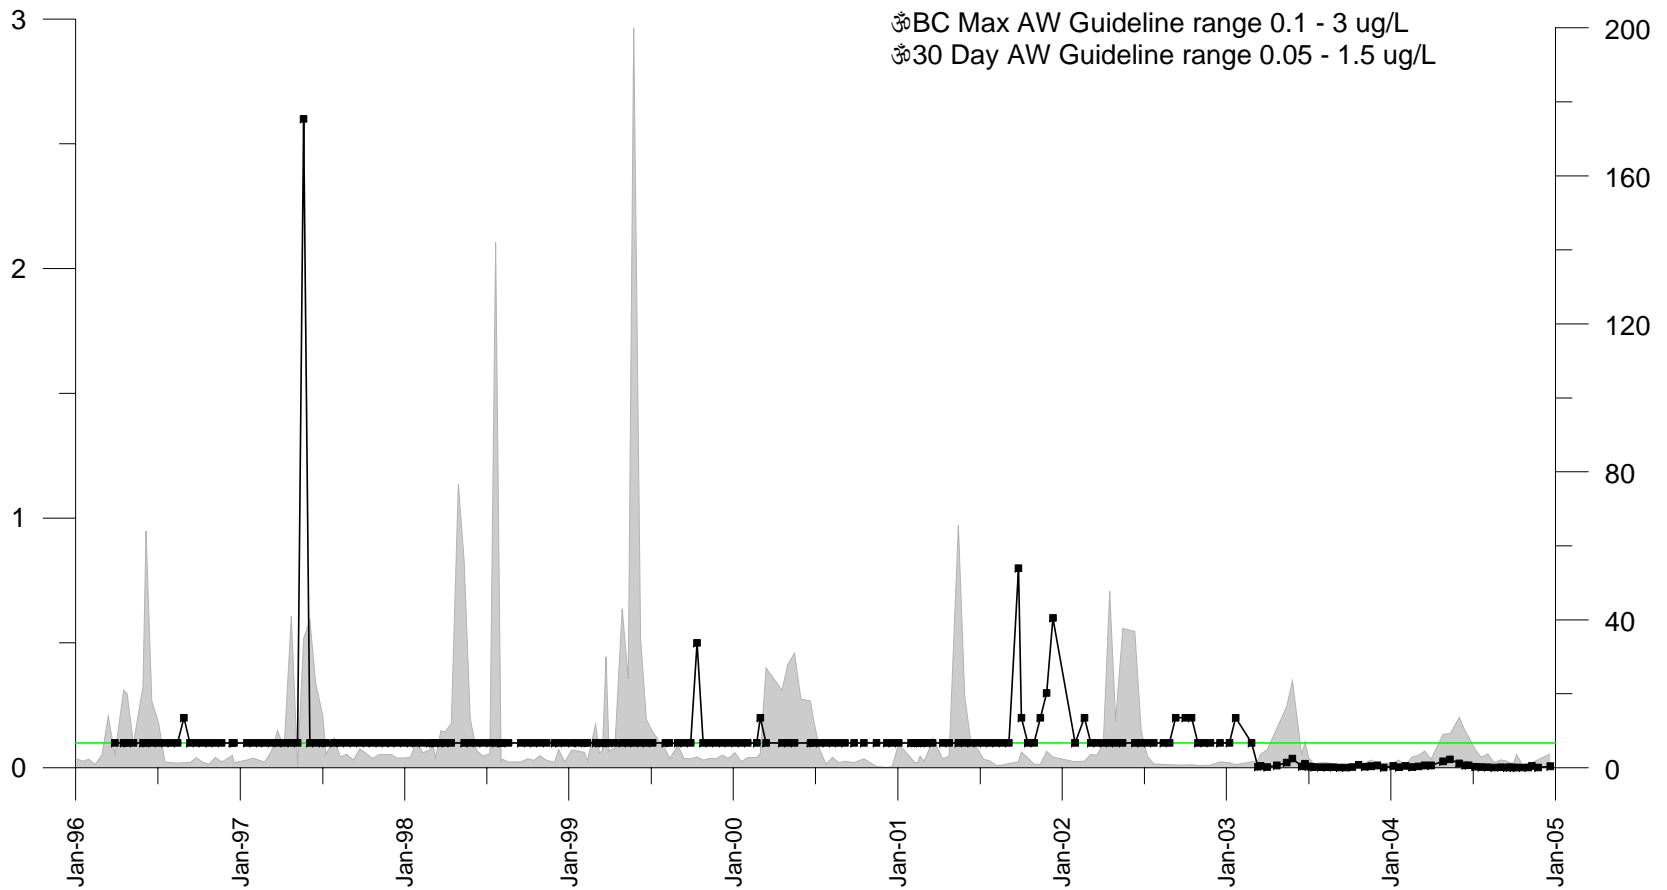
Figure 59

Silver (Figures 59 and 60): values on occasion exceeded the BC aquatic life guideline of 0.1 µg/L, but this usually happened when detection limits were at that level. The detection limit for silver was reduced to 0.001 µg/L in early 2003, and no values have exceeded the guideline since that time. Data from that latter period seem to fluctuate with turbidity concentrations, meaning that the higher silver values are related to particulate and not likely biologically available.

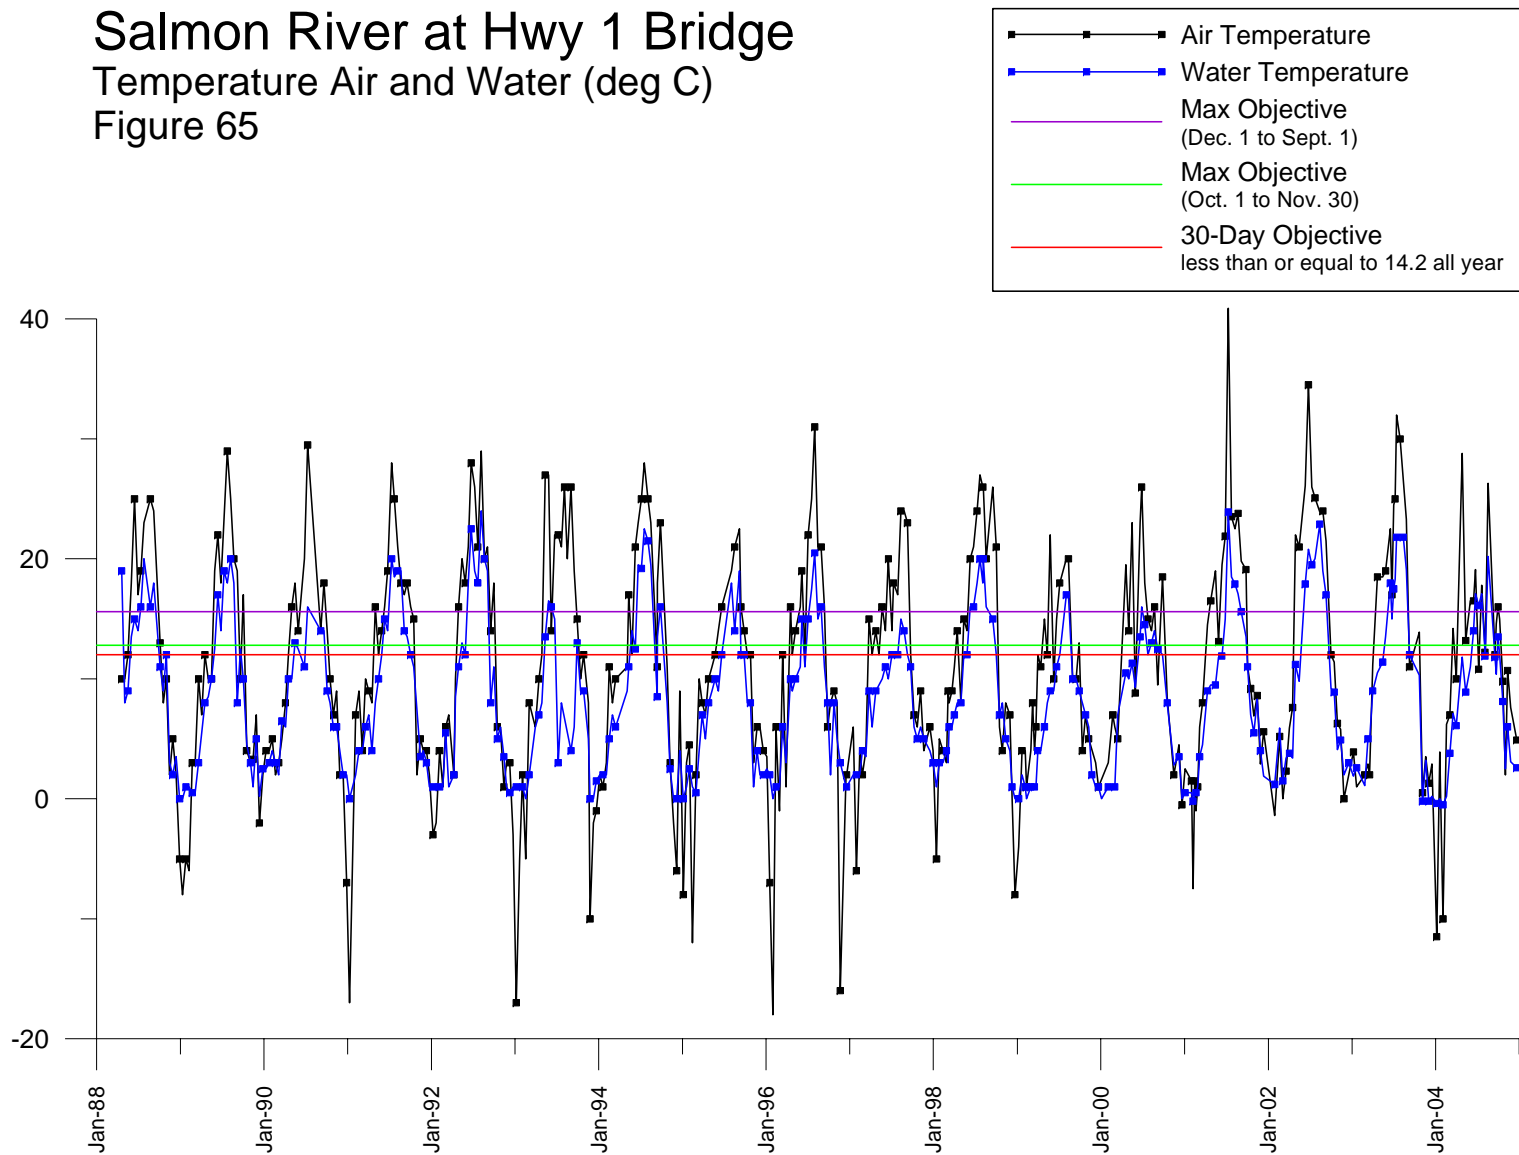
Salmon River at Hwy 1 Bridge
Temperature Air and Water (deg C)
Figure 65

Water Temperature (Figure 65): varies with flow and the time of year. Temperatures have exceeded objective levels especially during the hot summer periods.

- Water temperatures and dissolved oxygen often exceed water quality objectives, especially during the hot summer periods.
- Several metals exceeded guidelines or water quality objectives on occasion; however, these seemed to be correlated with turbidity and were likely in particulate form and not biologically available. Such metals included: aluminum, cobalt, chromium, copper, iron, lead, silver, and zinc. Cadmium also often exceeded guidelines, and was not always related to turbidity, which means that it could potentially be more available to aquatic life. This has just become evident over the past couple of years since the cadmium detection limit has decreased; cadmium will continue to be monitored at these low levels to track this potential concern.

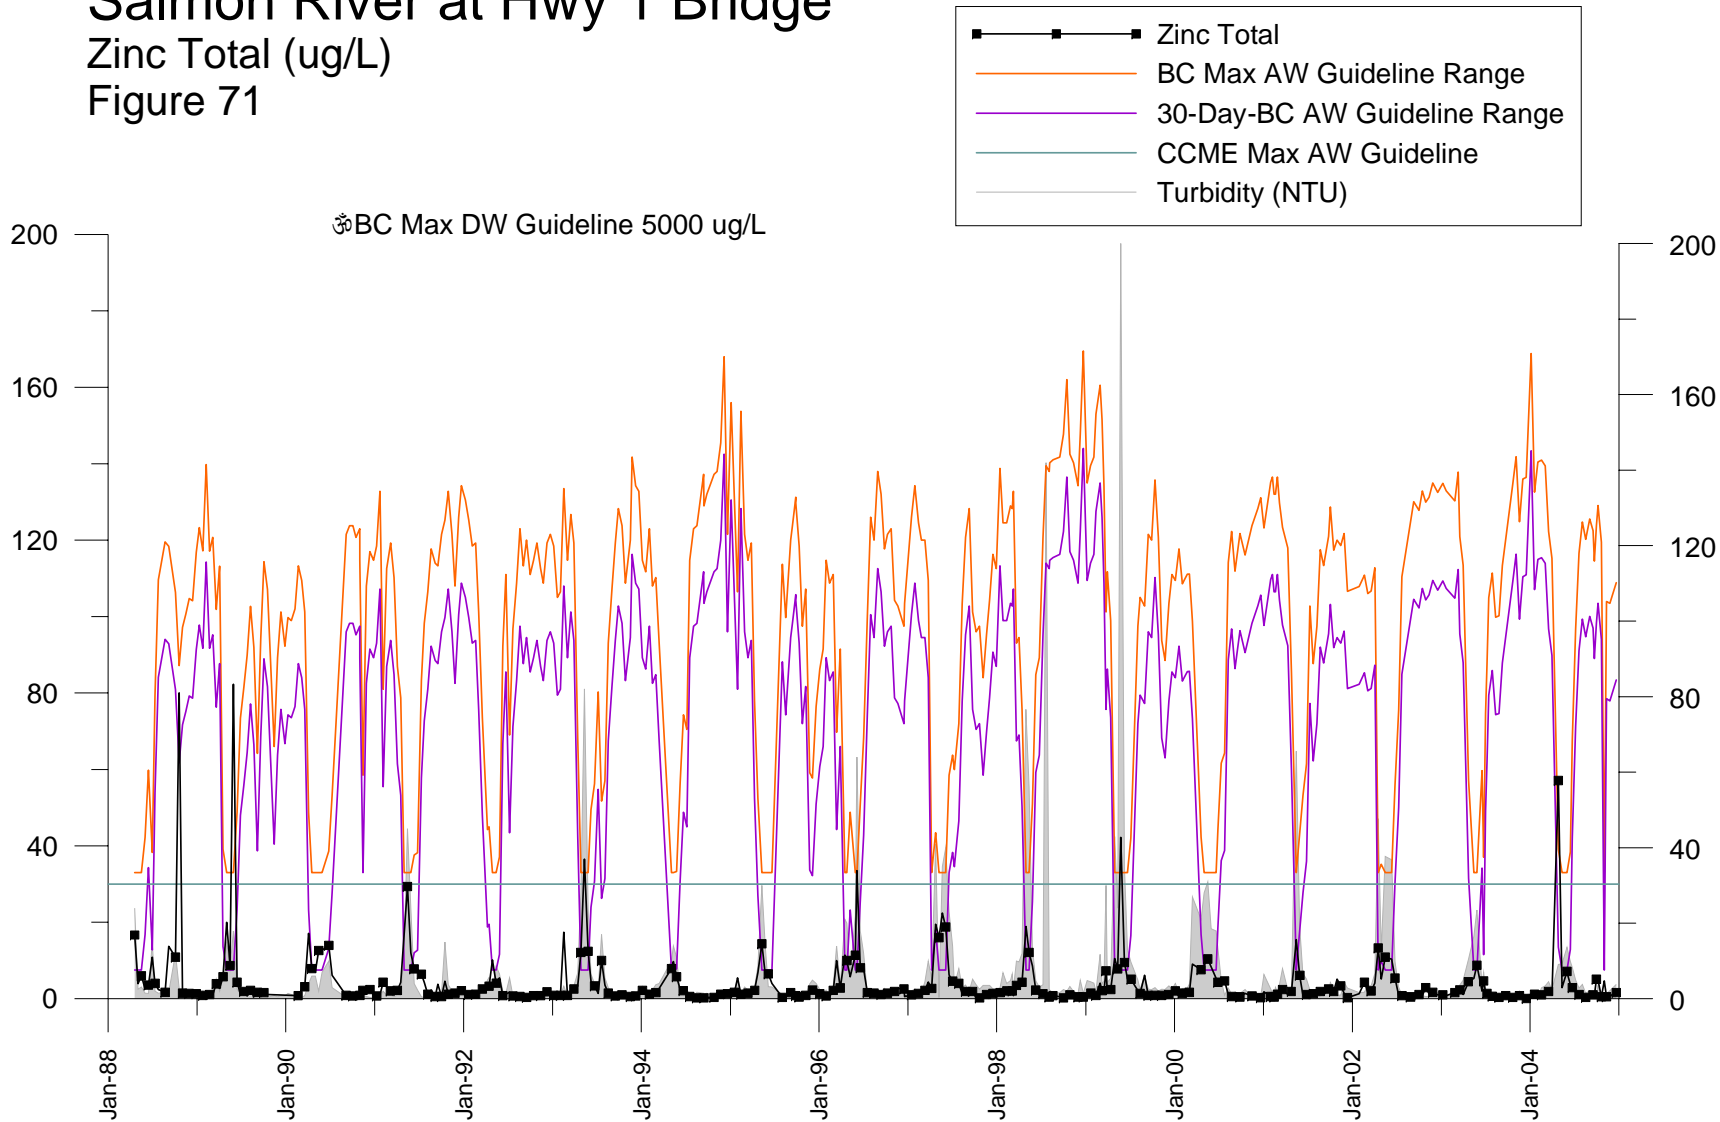
Figure 71

Zinc (Figures 71 and 72): values fluctuate with turbidity, which means that high values are associated with particulate matter and not likely biologically available. Occasional values exceed aquatic life guidelines that are hardness-dependent.
