## **WATER QUALITY MONITORING AGREEMENT**

### **WATER QUALITY ASSESSMENT OF SIMILKAMEEN RIVER AT US BORDER (1976 – 2000)**

Prepared by:  
Burke Phippen  
BWP Consulting

March, 2002

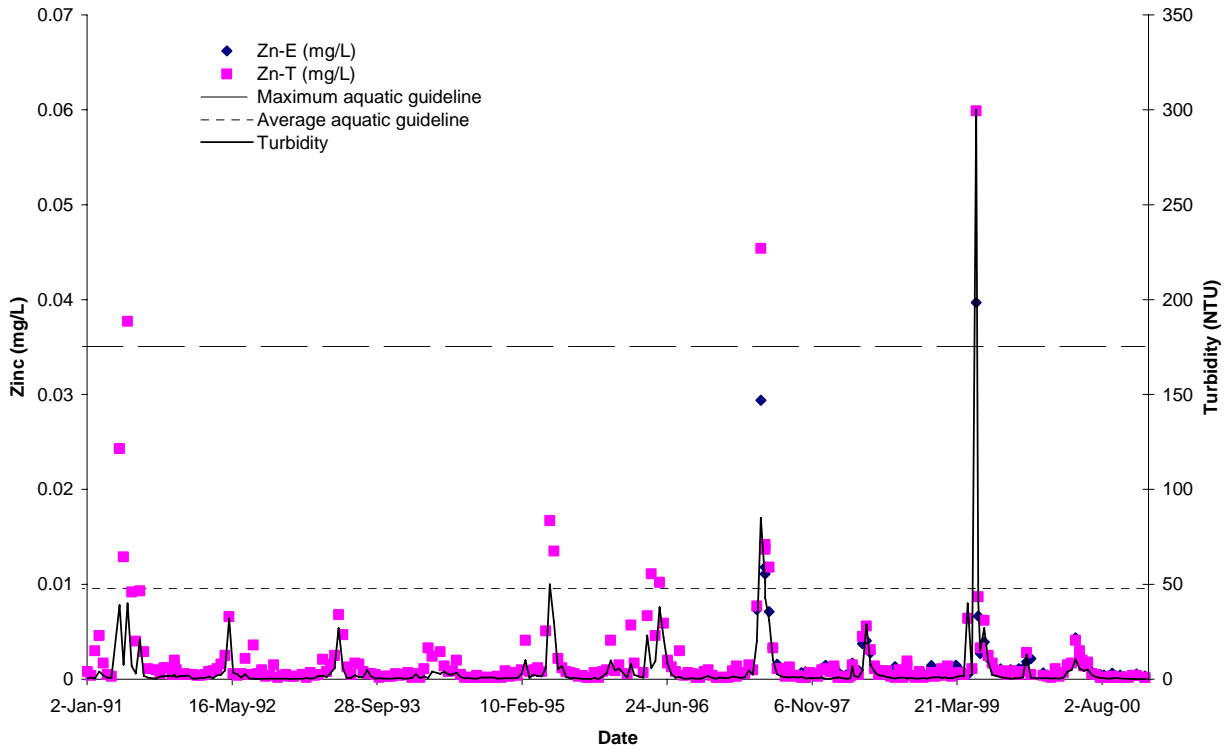
Figure 39. Similkameen River U/S U.S. Border - Zinc

**Total zinc** (Figure 39) values were high due to suspected preservative vial contamination between 1986 and 1990. Freshwater aquatic life guidelines are hardness dependent: at hardness values typical for the Similkameen River, the average guideline is 0.035 mg/L, while the maximum guideline is about 0.010 mg/L. Since 1990, three values (1% of the 272 samples) exceeded the maximum objective, while sixteen values (6% of samples) exceeded the average objective (Figure 39). There was a good correlation between elevated zinc levels and elevated turbidity (Figure 39), suggesting that the zinc was associated with particulate matter and not likely bioavailable. However, the fact that extractable zinc concentrations also exceeded the guidelines on these occasions suggests that zinc may occasionally be a problem in the Similkameen River. There does not appear to be any trend in zinc concentrations over time at this site.
